Property Inspection Report

1234 Sample St.
Inspection Prepared For: Smith John
Agent: Barrett Espinola -

Date of Inspection: 11/9/2020
Year Built: 2003 Size: 4500 SF
Weather: Dry 86

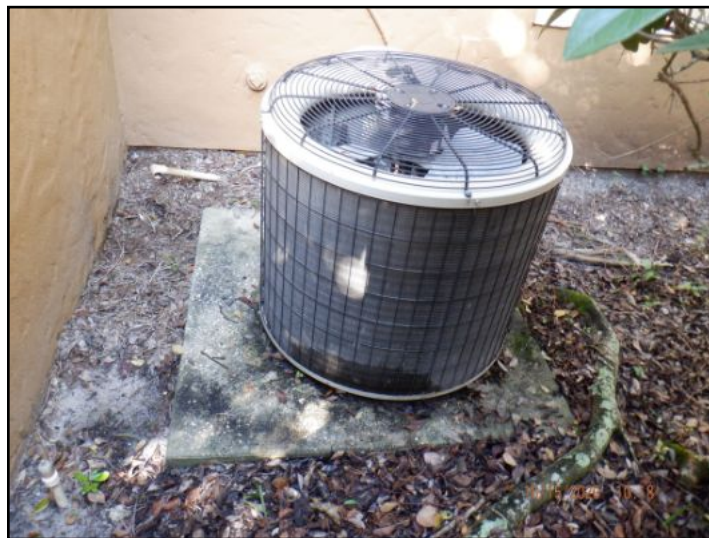
Page 28 Item: 3	AC Compress Condition	<ul style="list-style-type: none"> The East AC unit is a Payne 2003 3 Ton unit. The unit performed to industry standards during time of inspection. I observed excessive vibrating and noise at time of inspection. The average life expectancy for air conditioners is 15-20 years and this unit is 17 years old. I recommend having a qualified professional further evaluate and budgeting for a new unit.
-----------------	-----------------------	--

East Payne 2003 3 Ton R22

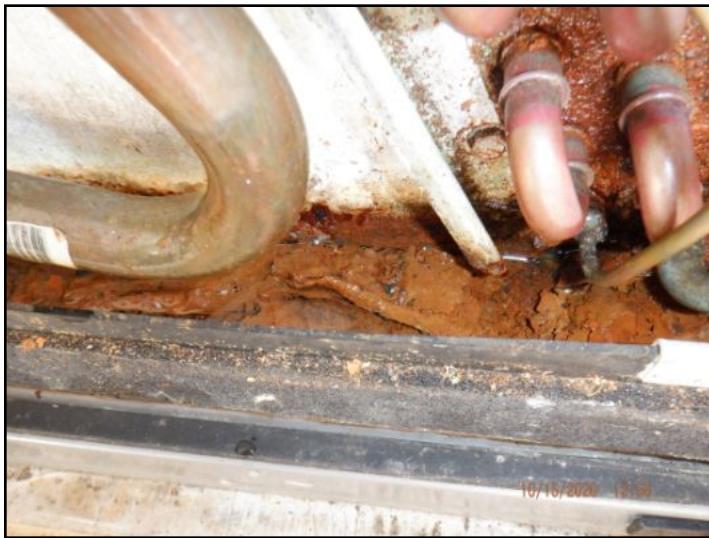
Garage air handler corrosion

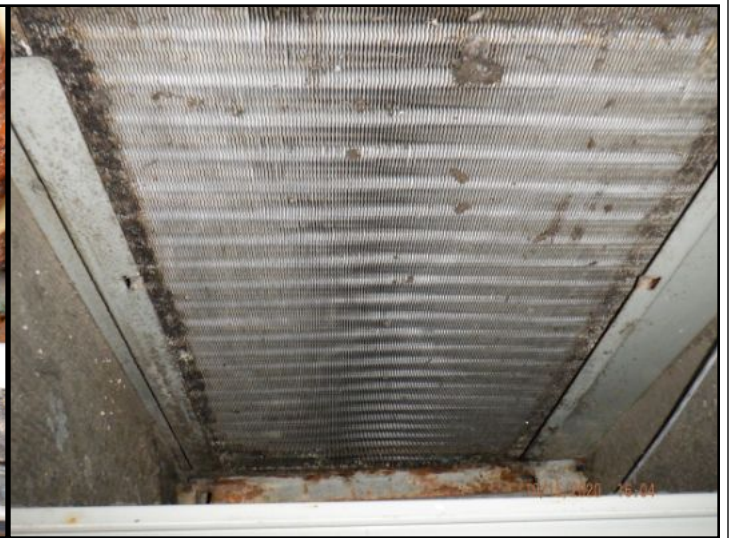
Page 29 Item: 4	Air Supply	<ul style="list-style-type: none"> The air handler located in the master bedroom closet is a Payne 2003 3 ton unit. It performed to industry standards but based on visible conditions at the time of the inspection, I advise complete and proper review of the HVAC system by a qualified professional. I noted corrosion of coils, dirty fins and lack of maintenance. The unit is 17 years old. I recommend budgeting for a new unit.
-----------------	------------	--

Master air handler dirty coils

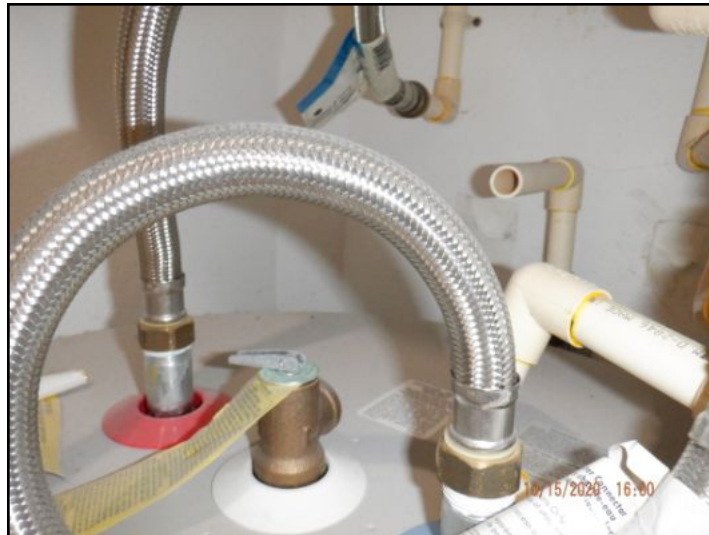
Page 34 Item: 2	TPRV	<ul style="list-style-type: none"> The TPRV piping is not connected at the GE master closet water heater at time of inspection. This is a serious safety concern and needs to be corrected. I recommend contacting a licensed plumber for repairs.
-----------------	------	---

Master closet TPRV is not connected

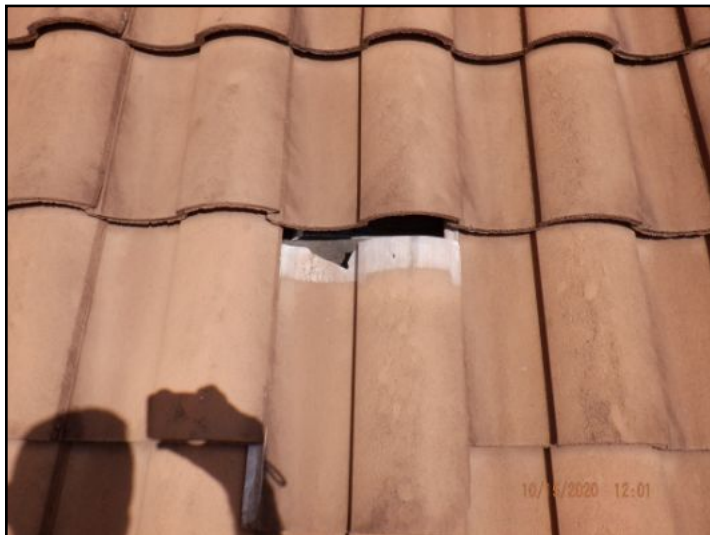
Page 41 Item: 1	Roof Condition	<ul style="list-style-type: none"> I observed multiple areas of roof damage at time of inspection. I noted slipping and cracked tiles. There was evidence of water intrusion on the roof decking in the attic that was dry during time of inspection. I recommend further evaluation by a qualified professional for repair options.
-----------------	----------------	---

Sliding tile

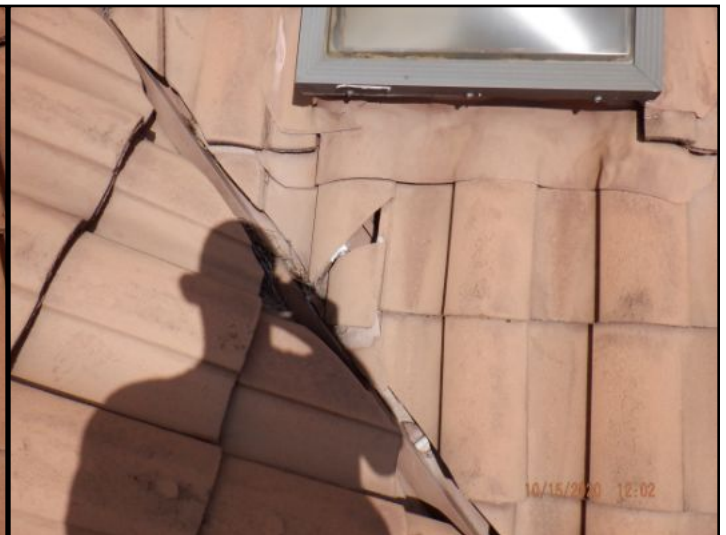
Broken tile

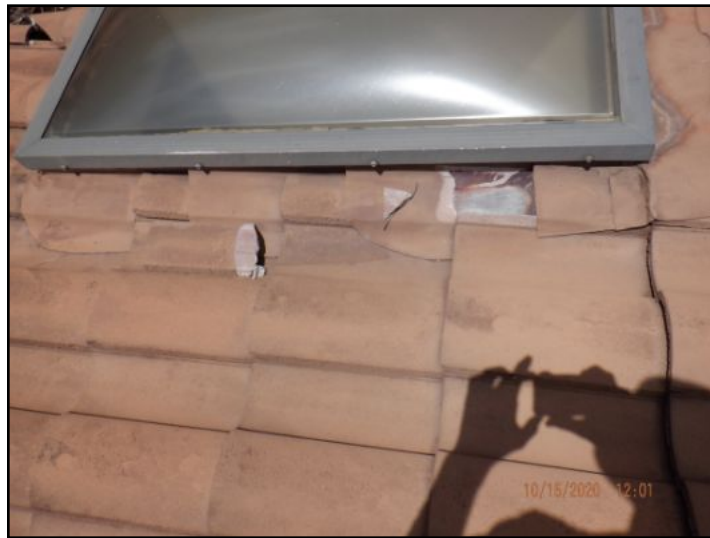
Flashing damage

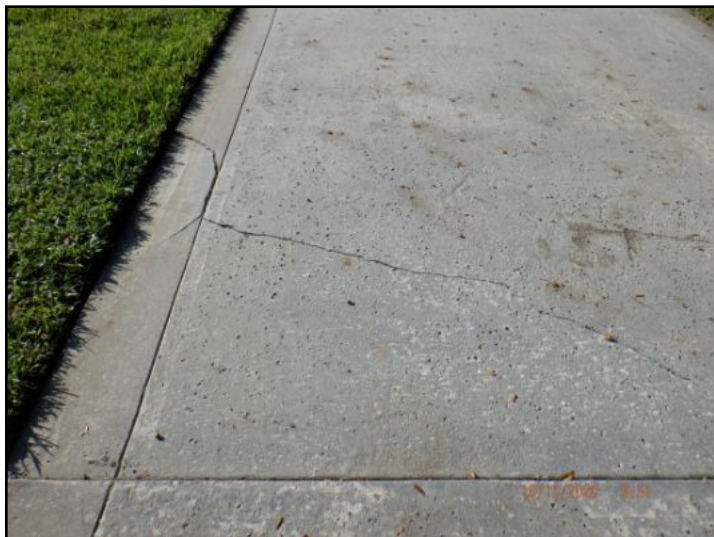
- **IMPROVE:** Typical cracking was observed at the concrete surfaces. Further deterioration will occur as water expands and contracts with temperature change. Recommend monitoring and sealing the cracks to prolong the life of the concrete.
- No major system safety or function concerns noted at time of inspection.

Settlement cracks

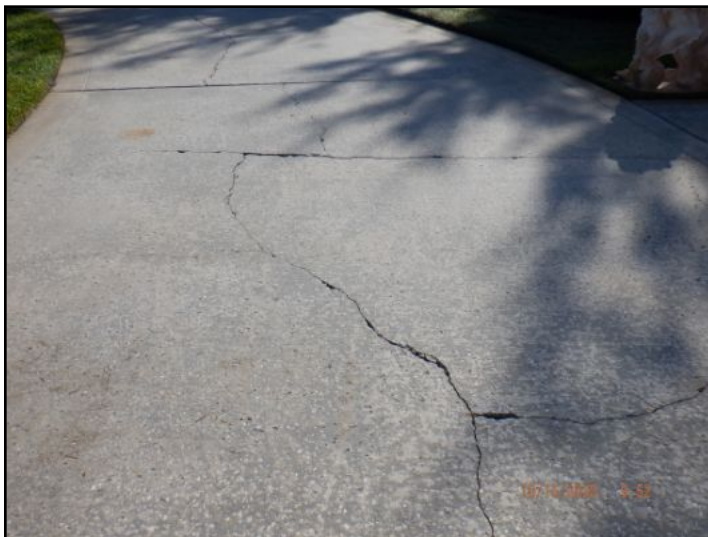
Settlement cracks

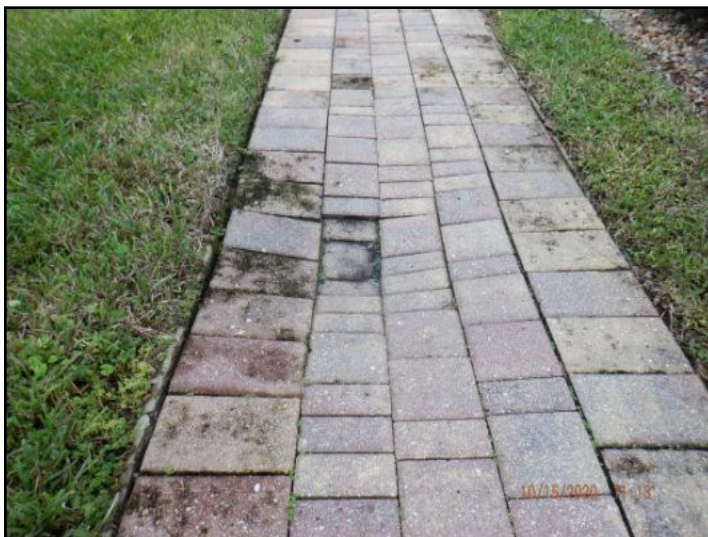
South walk way Trip hazard

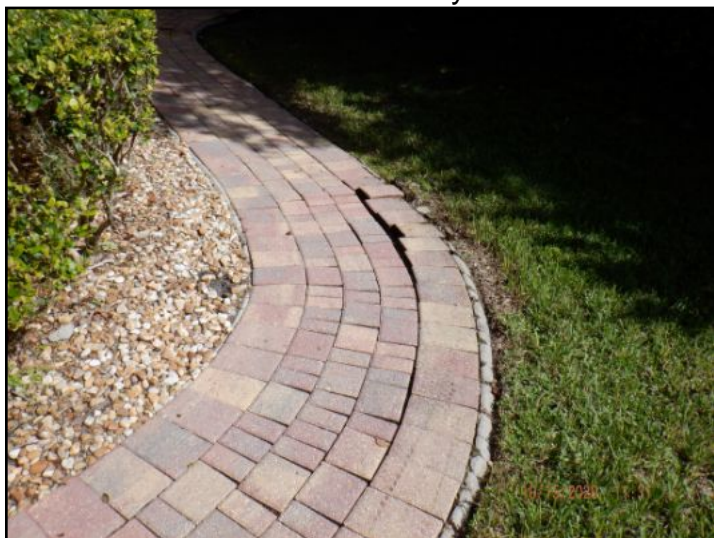
East walk way trip hazard

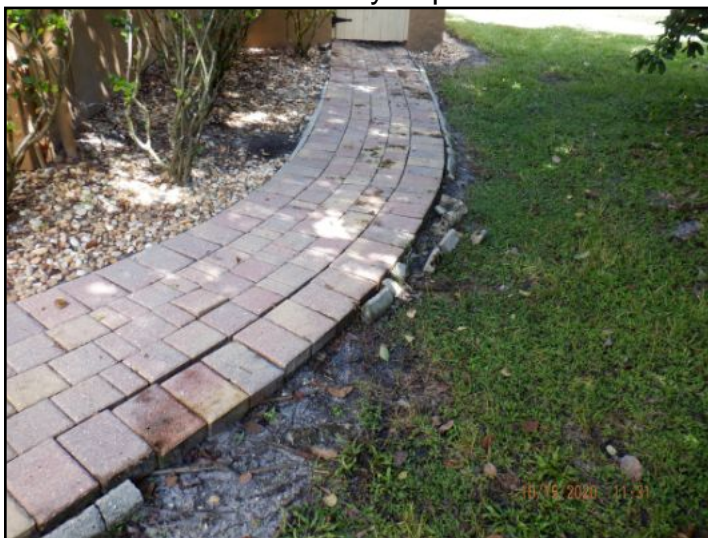
East walk way trip hazard

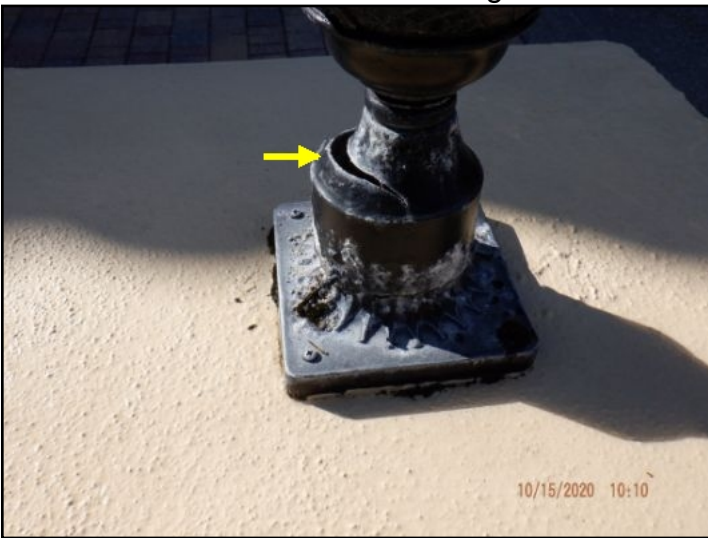
North front walkway light damage

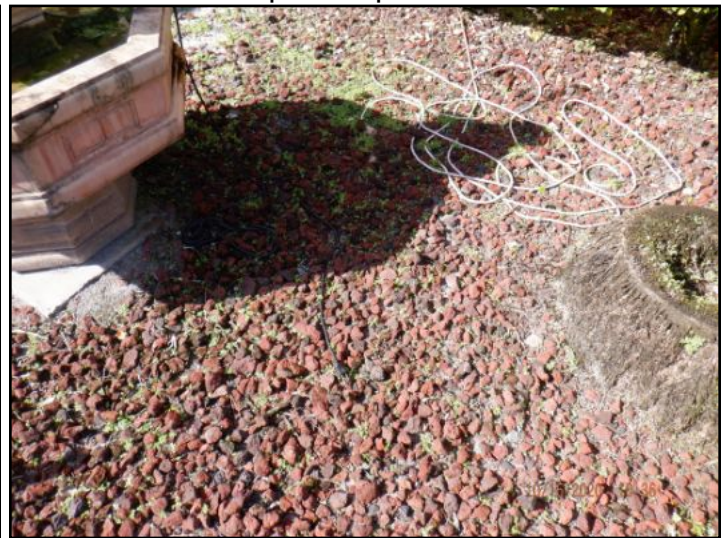
Front fountain running off of extension cord

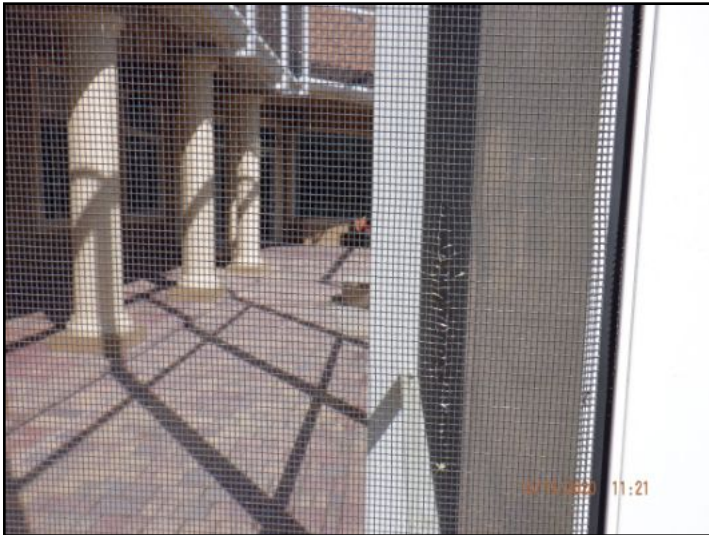
Observations:
• I observed multiple areas of screen damage on the pool enclosure. I believe the screen is near/at the end of its useful life. I recommend a qualified professional further evaluate and repair/replace as needed.

Damaged screen

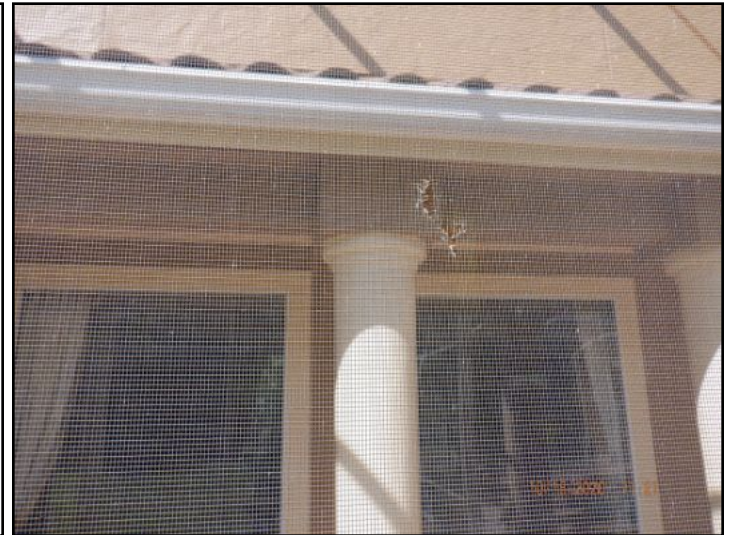
Damaged screen

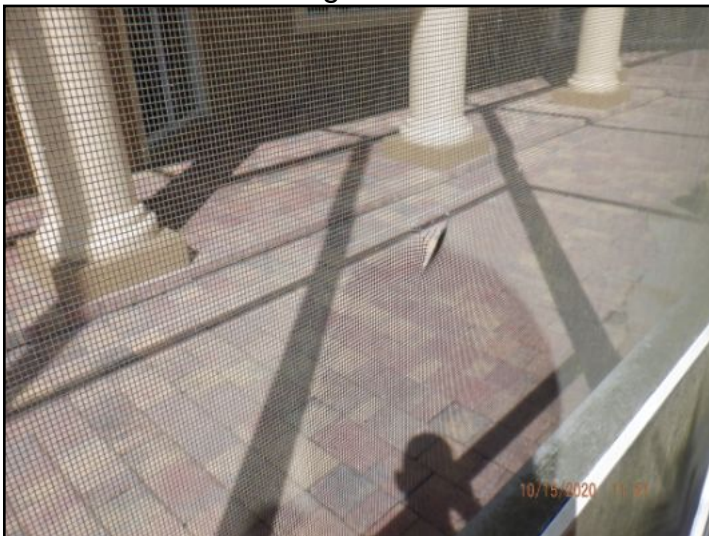
Damaged screen

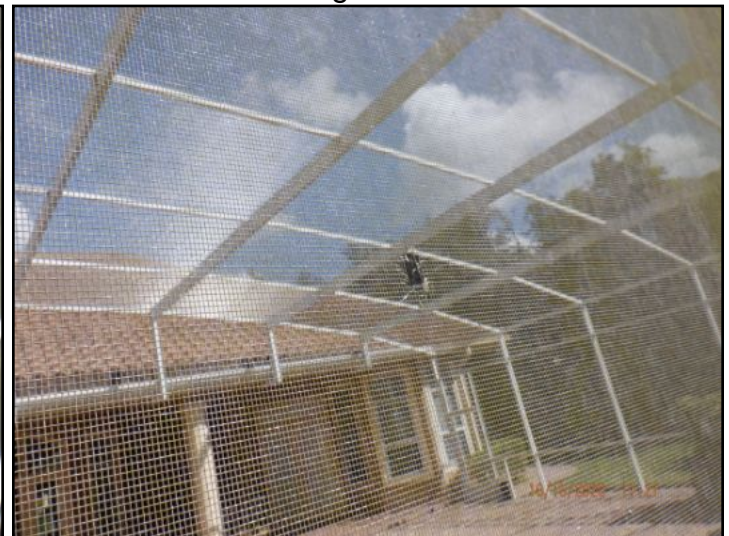
Damaged screen

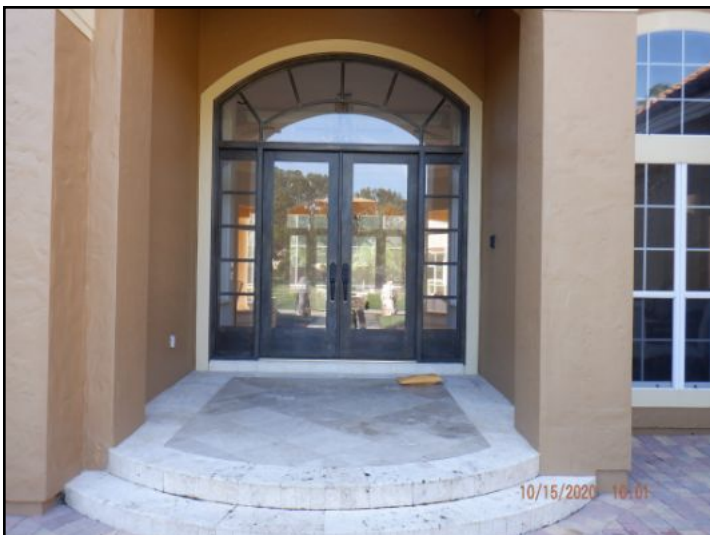
Front

- I observed door and door frame wood rot at the West exterior entry door. I recommend repairs to prevent pest intrusion and further damage.

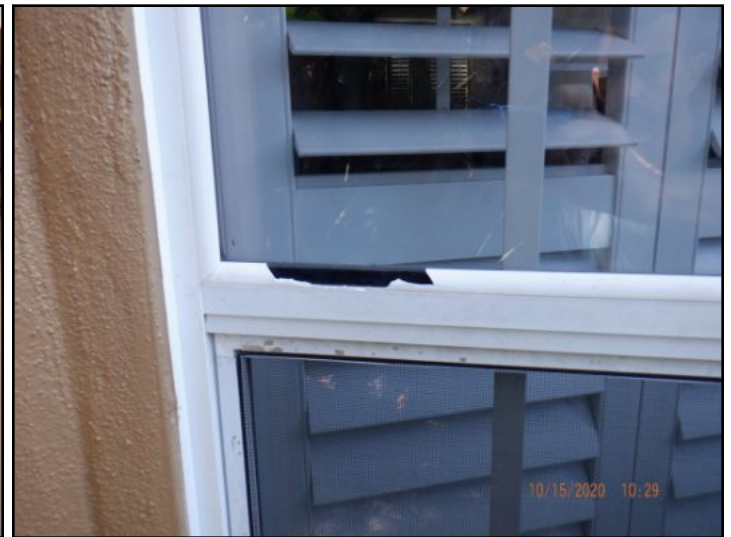
- Vinyl frame single hung windows noted.
- I observed window frame damage at one or more locations on the home. Recommend review by a qualified professional for repair or replacement, as necessary, prior to close.

North East corner window frame damage

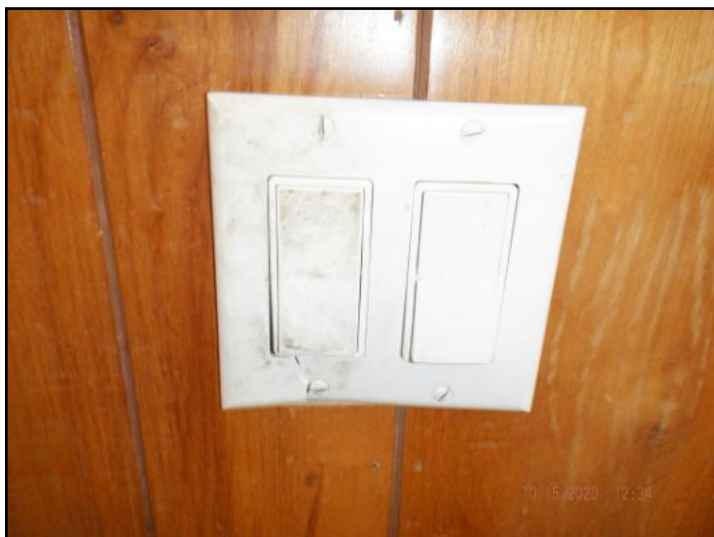
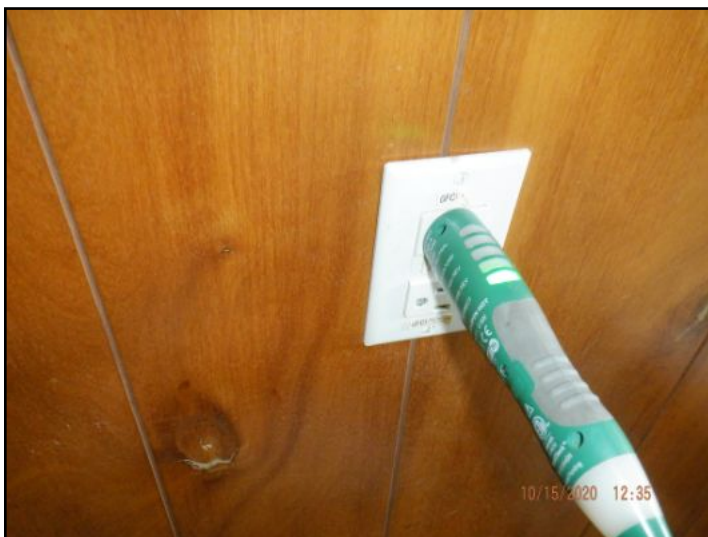
- I observed a damaged switch cover plate at the garage service entrance. Repair or replace to prevent shock hazard.

Switch cover damage

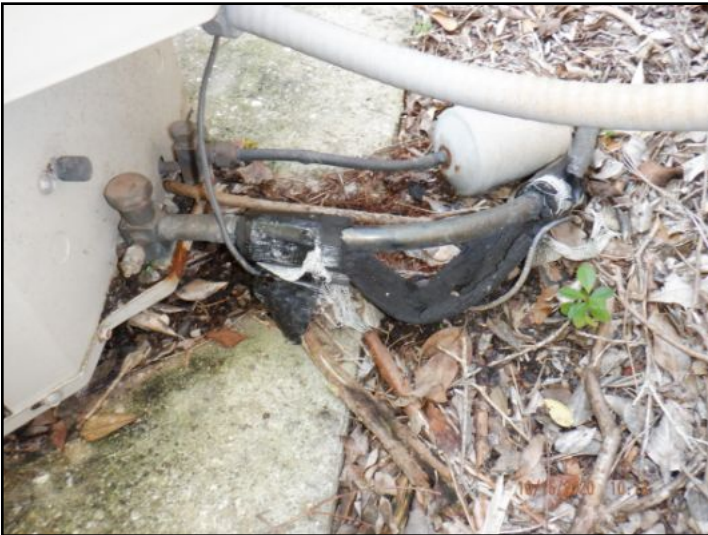
- Missing insulation at **A/C** unit.

East AC Insulation damage

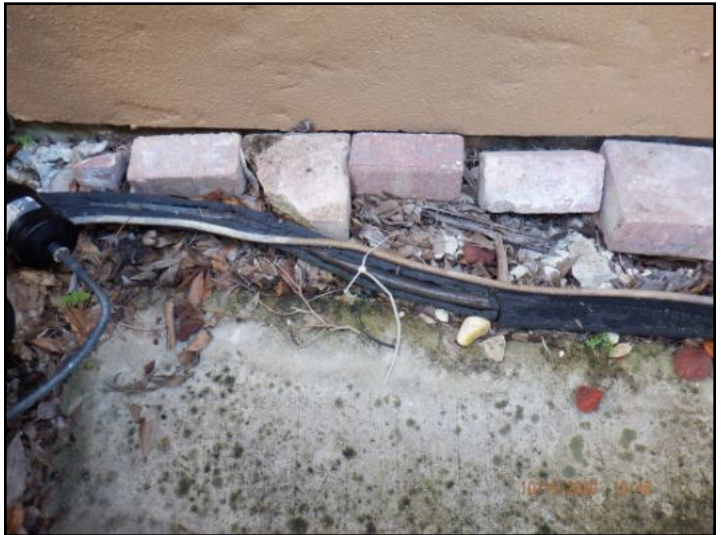
West Insulation damage

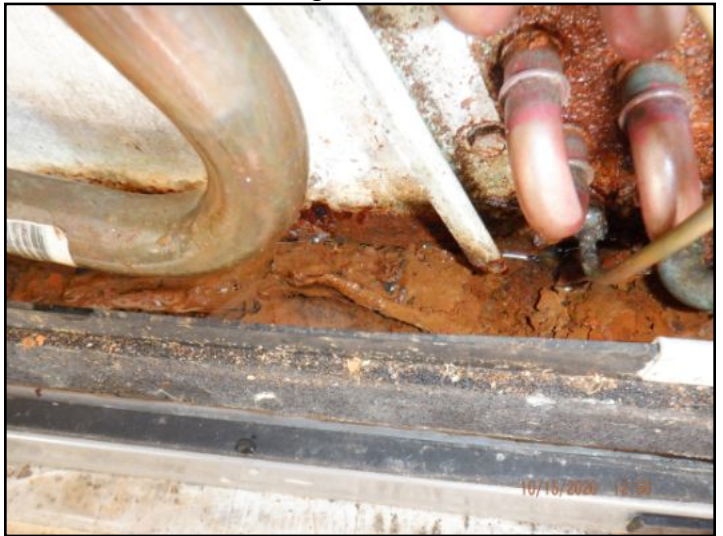
Garage air handler corrosion

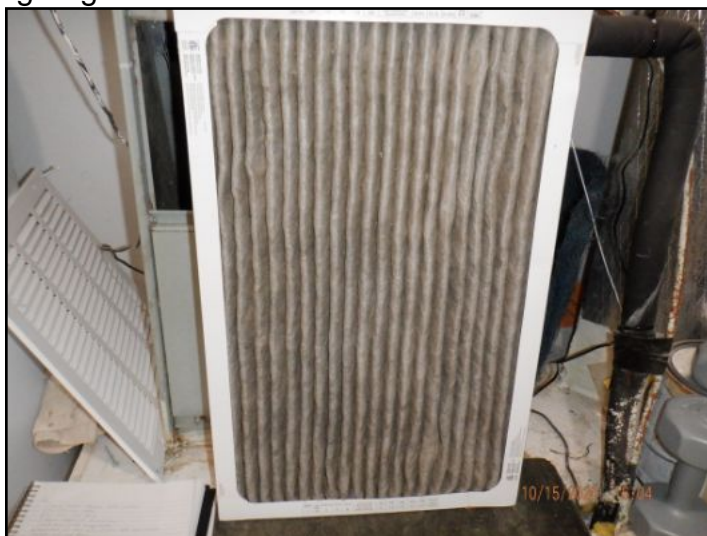
Master replace filter

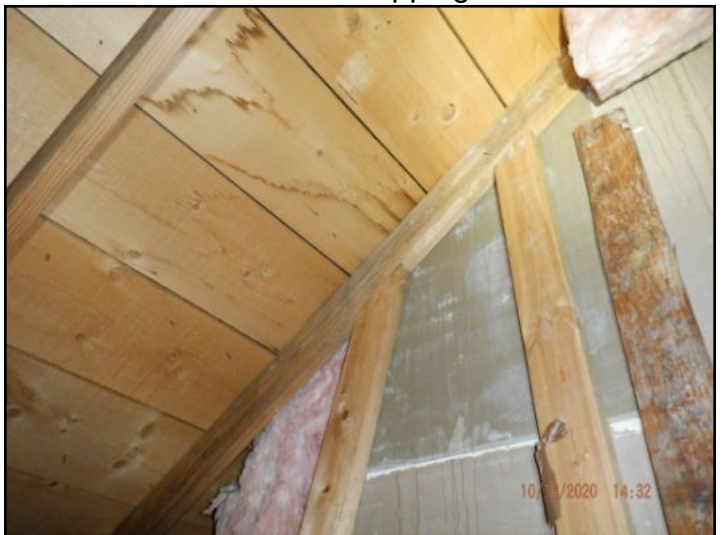
- Attic appeared to be of sound structure during time of inspection.
- Evidence of past or present leaks, dry at time of the inspection. (see roof skylight section) Monitor for leaks &/or have roofing contractor evaluate.

Water stains around skylight dry

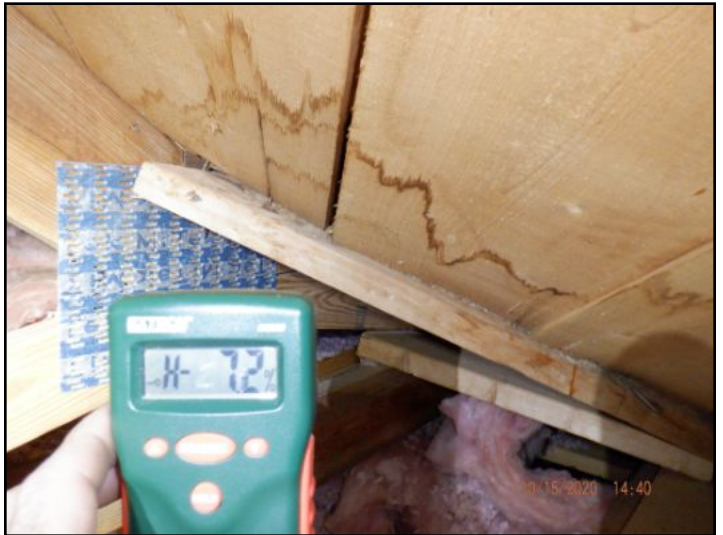
Water stains around skylight dry

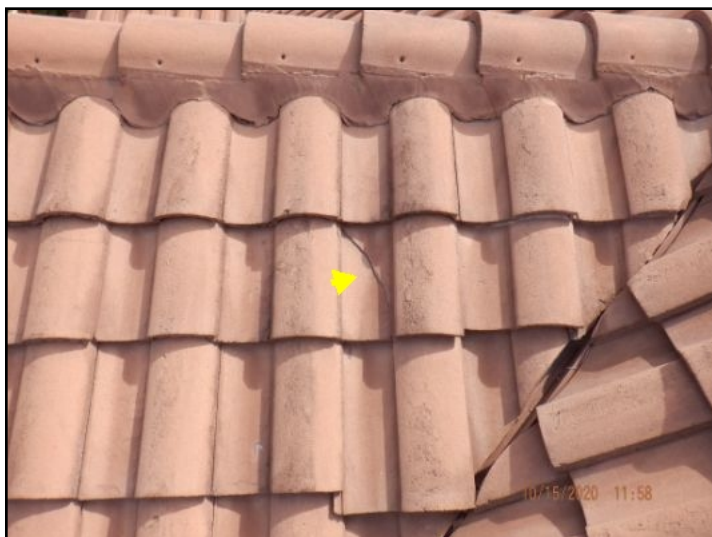
- WE DO NOT CERTIFY ROOFS AS LEAK-PROOF as part of a General Home Inspection. If you would like the roof of this property certified against leakage, you should contact a qualified roofing contractor who provides this service.
- I observed multiple areas of roof damage at time of inspection. I noted slipping and cracked tiles. There was evidence of water intrusion on the roof decking in the attic that was dry during time of inspection. I recommend further evaluation by a qualified professional for repair options.

Crack

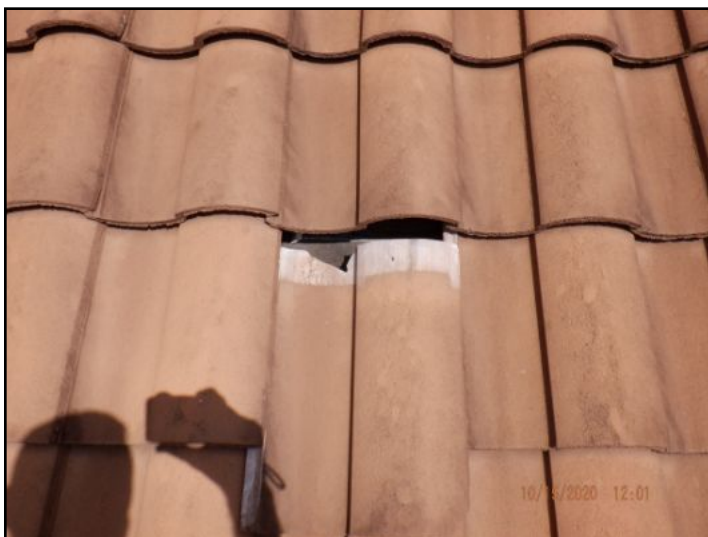
Sliding tile

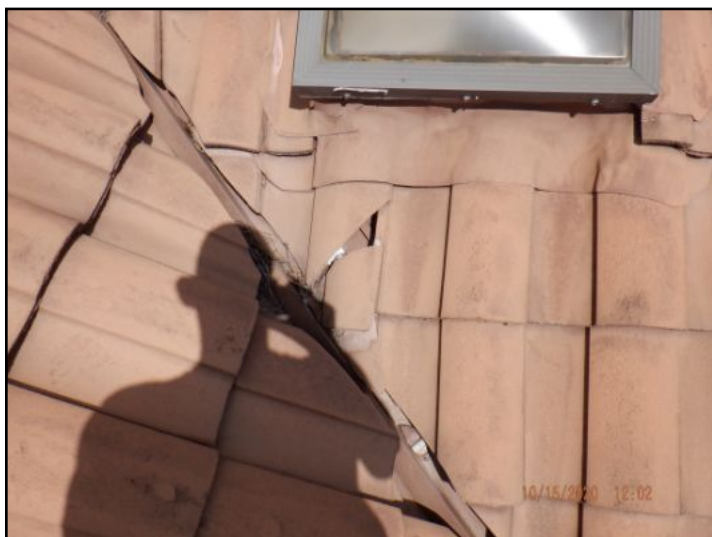
Broken tile

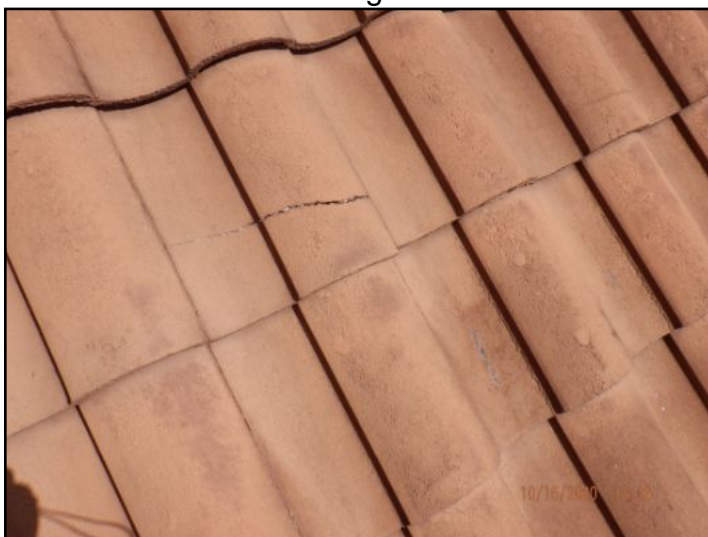
Cracks

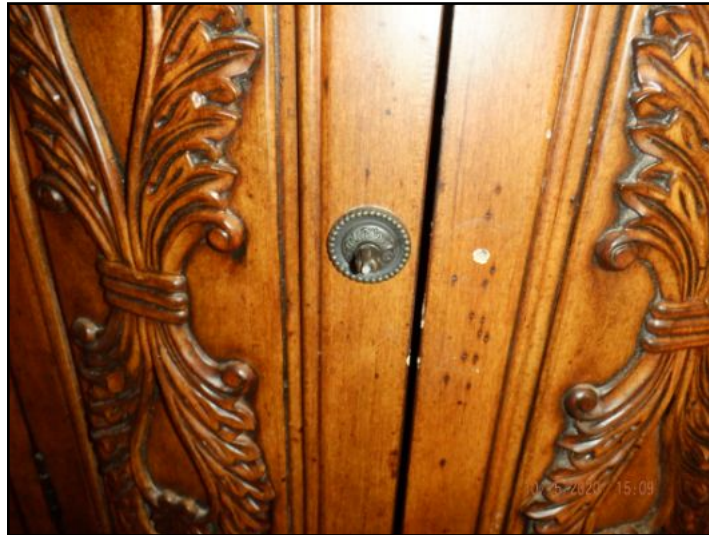
- Cabinet doors missing hardware. This makes the doors difficult to open.

West bathroom missing knob

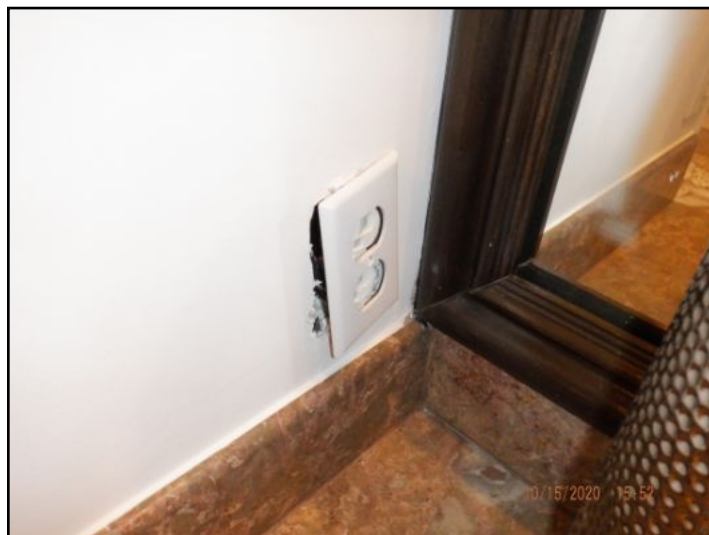
- The Master bathroom sink outlet is loose. I recommend repair by a qualified professional to prevent electrocution hazard.

Loose outlet Master

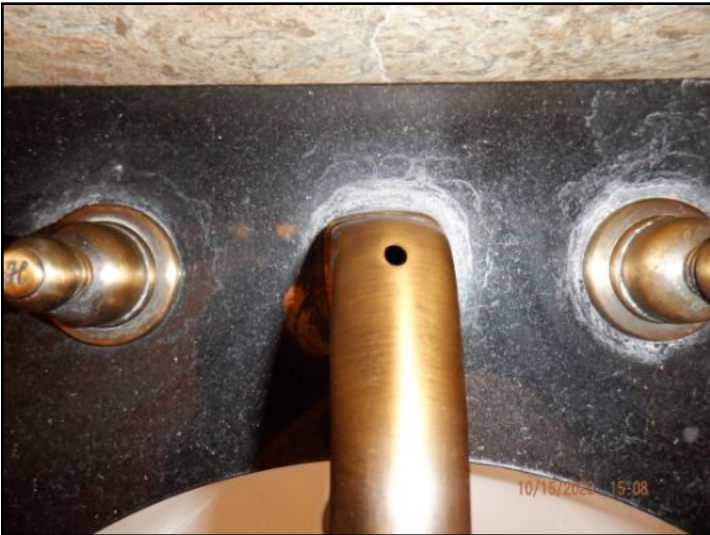
- The west bathroom sink was missing the drain stopper and knob.

West bathroom Missing drain stopper

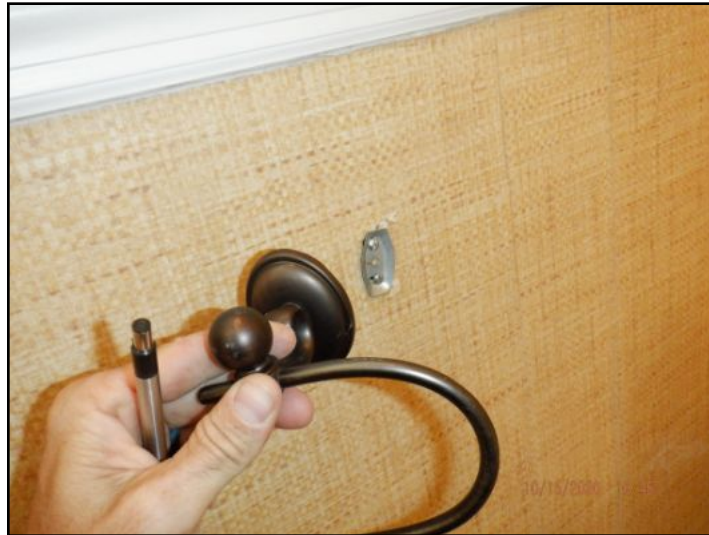
- Loose toilet paper holder repair as necessary.

South bath Damaged toilet paper hanger
