Inspection Report

Property Address:
1000 Glenwick Dr
Windermere FL 34786

Home Inspections by PJM Inc.

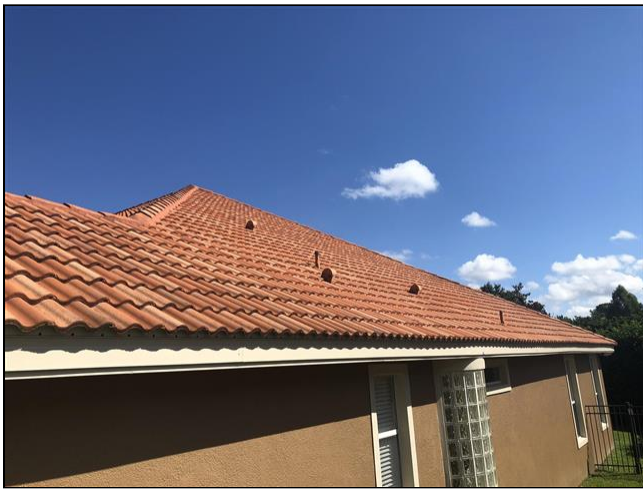
1.0 Item 1(Picture) Roof View

1.0 Functional at time of inspection.

Age 14 years Life expectancy based on 50 + years for tile roof systems is 36+ years left.

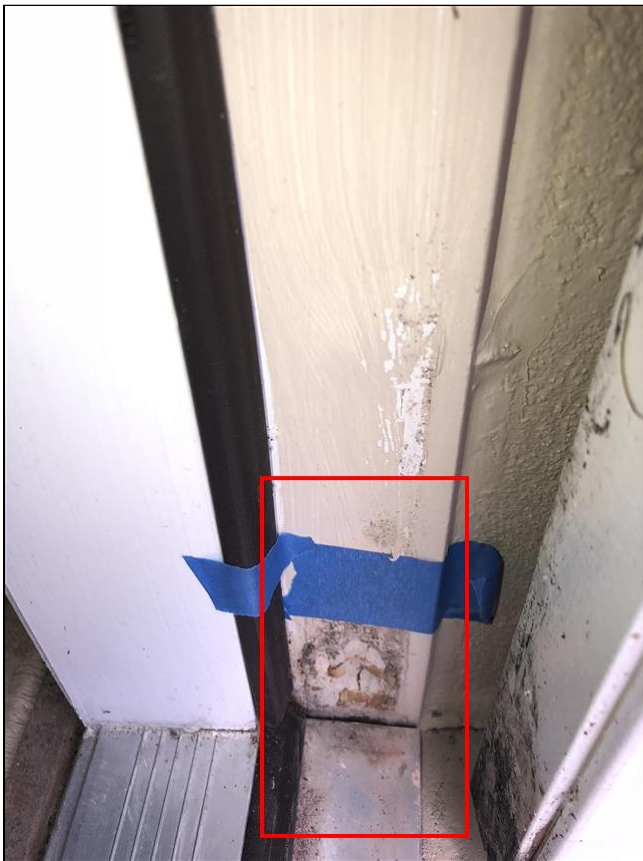
2.1 Item 1(Picture) Left Side Lower Frame Pool Bath Exterior Door

2.1 (1) **Wood rot fungi present at the pool bath exterior door frame. Recommend repair by a qualified person.**

- (1) **Wood rot fungi present at the pool bath exterior door frame. Recommend repair by a qualified person.**
- (2) **Wood rot fungi present at the master bedroom exterior door frame. Recommend repair by a qualified person.**

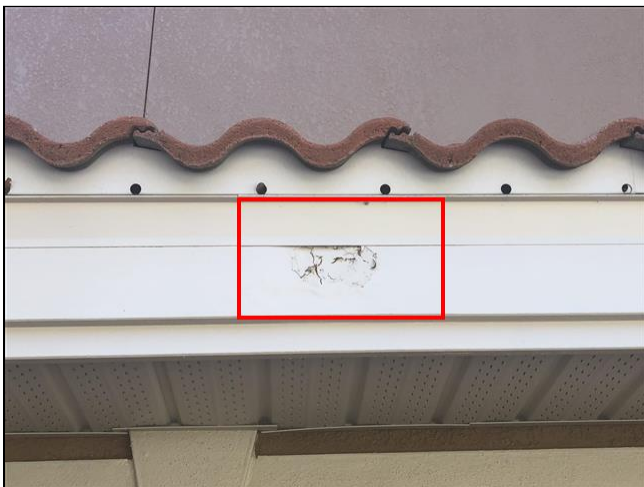
2.5 Item 1(Picture) North Side

2.5 **Visible wood rot fungi or water damage at the fascia board located in areas. Recommend repair by a qualified person.**

Visible wood rot fungi or water damage at the fascia board located in areas. Recommend repair by a qualified person.

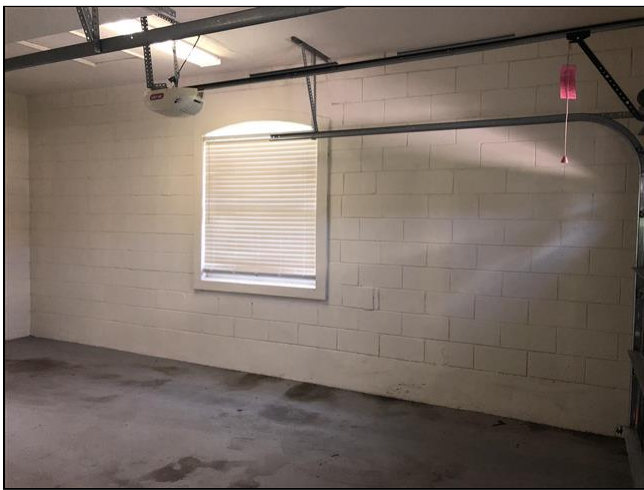
3.1 Item 1(Picture) West Wall

3.1 Functional at time of inspection.

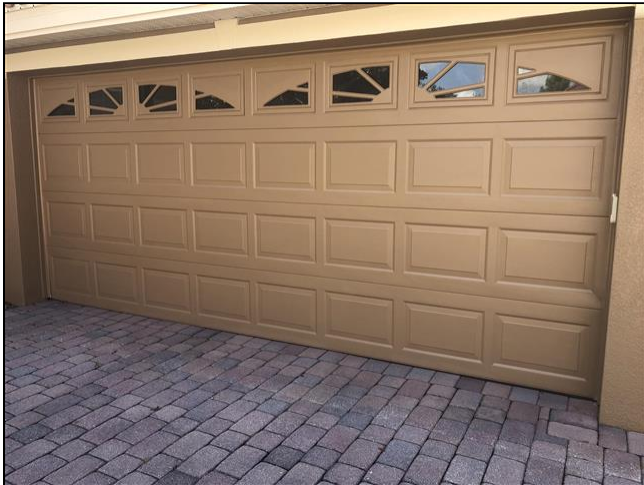
3.3 Item 1(Picture) Two Car Garage Door

3.3 Functional at time of inspection.

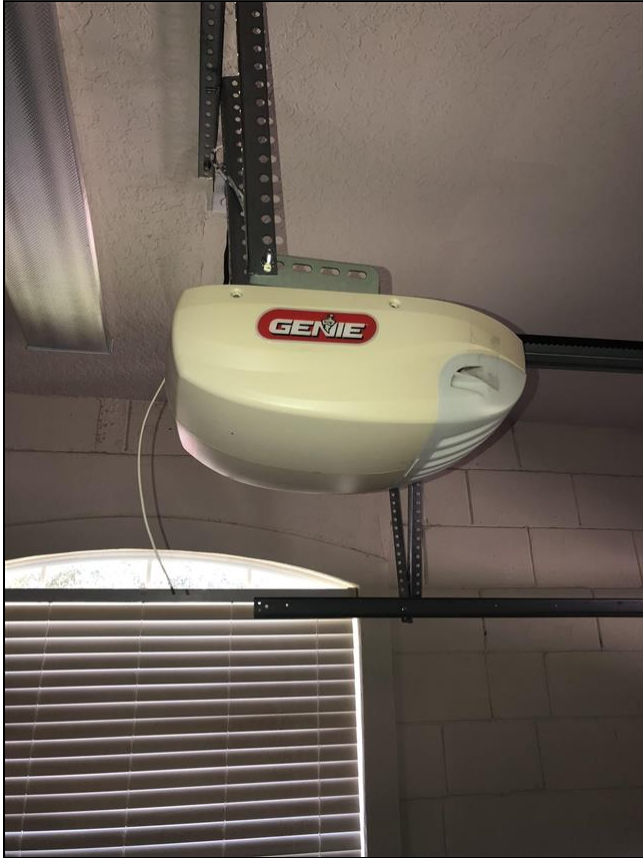
3.5 Item 1(Picture) Single Car Garage Door Operator

3.5 (1) Single car garage door operator would operate but not open door at time of inspection. Recommend repair by a qualified person.

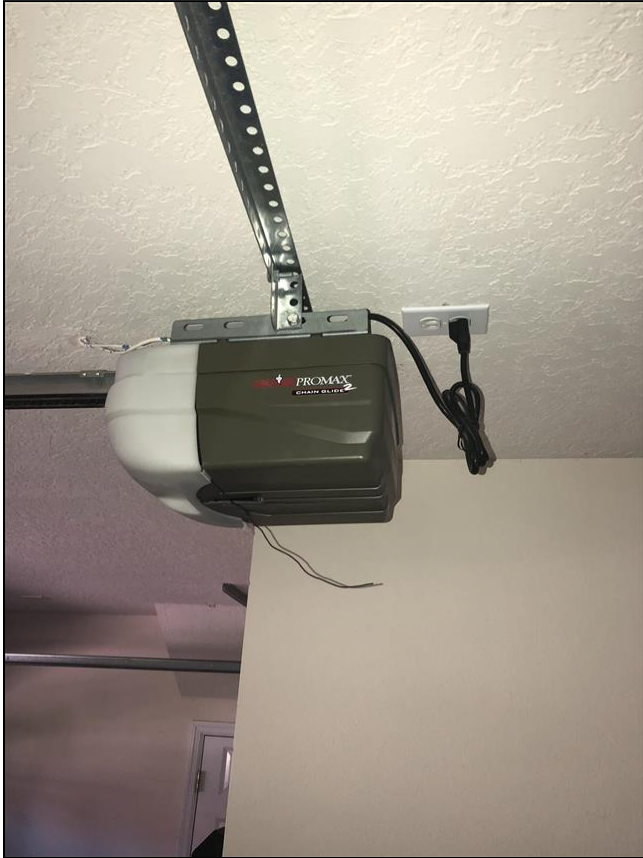
3.5 Item 2(Picture) Two Car Garage Door Operator

(2) Two car garage door operator was functional but would not reverse when tested. Recommend repair by a qualified person.

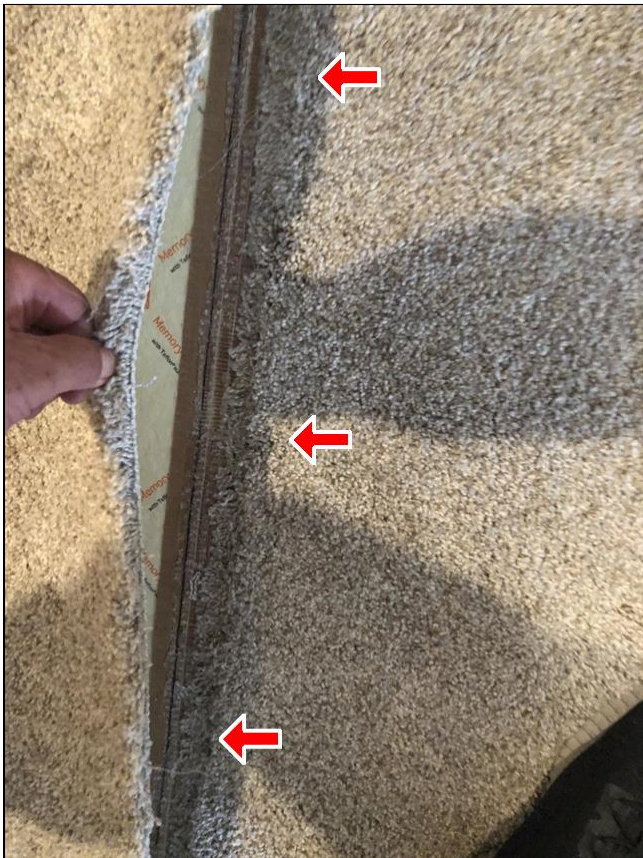
4.2 Item 1(Picture) Bonus Room

4.2 **Carpet seam located in bonus room was not functional at time of inspection. Recommend repair by a qualified person.**

Carpet seam located in bonus room was not functional at time of inspection. Recommend repair by a qualified person.

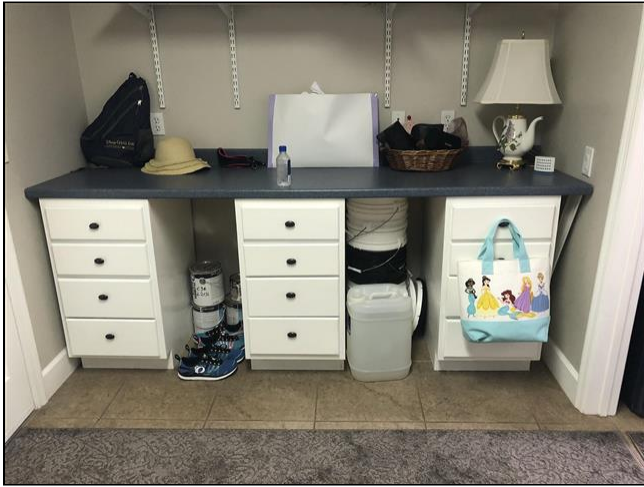
4.4 Item 1(Picture) Mud Room

4.4 (1) **Cabinets and counter top located in mud room are not installed as permanent. The counter top is laying on the cabinets. Recommend repair by a qualified person.**

(1) Cabinets and counter top located in mud room are not installed as permanent. The counter top is laying on the cabinets. Recommend repair by a qualified person.

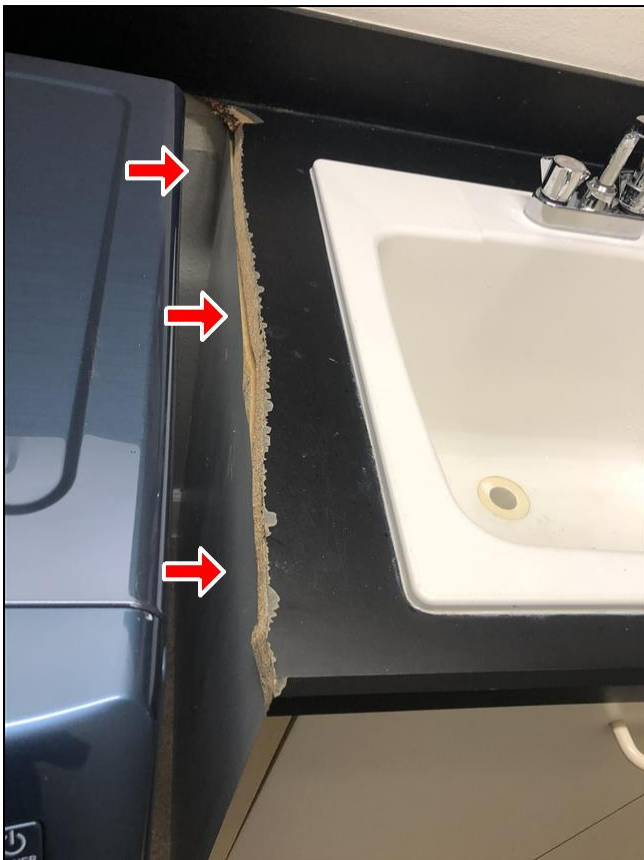
4.4 Item 3(Picture) Laundry Room

(2) **Laundry room counter was cut and not finished this is for your information.**

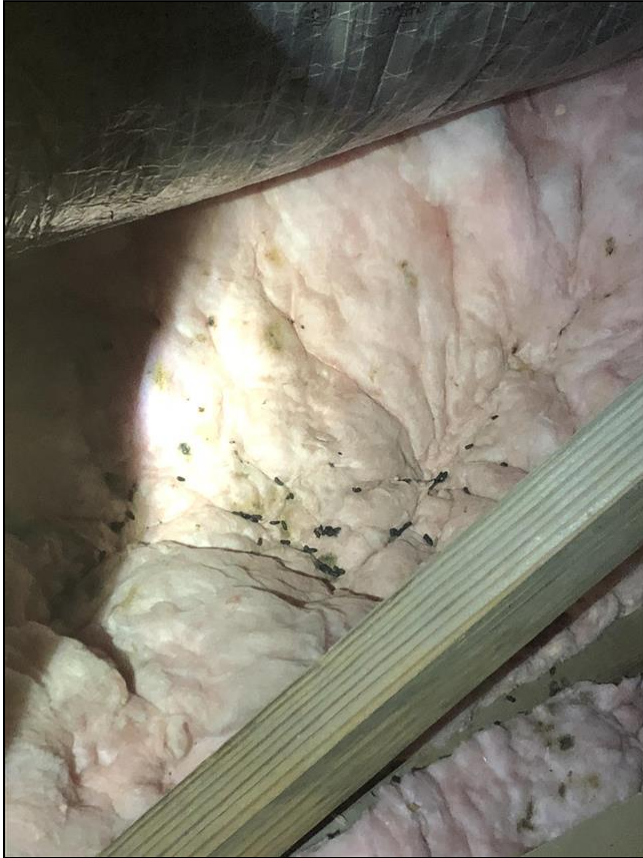
5.5 Item 1(Picture) Rodent Droppings

5.5 Rodent droppings present attic access at the second floor access. Rat traps in the attic and dead rat was visible in rat trap. Recommend further evaluation by a critter control company.

Rodent droppings present attic access at the second floor access. Rat traps in the attic and dead rat was visible in rat trap. Recommend further evaluation by a critter control company.

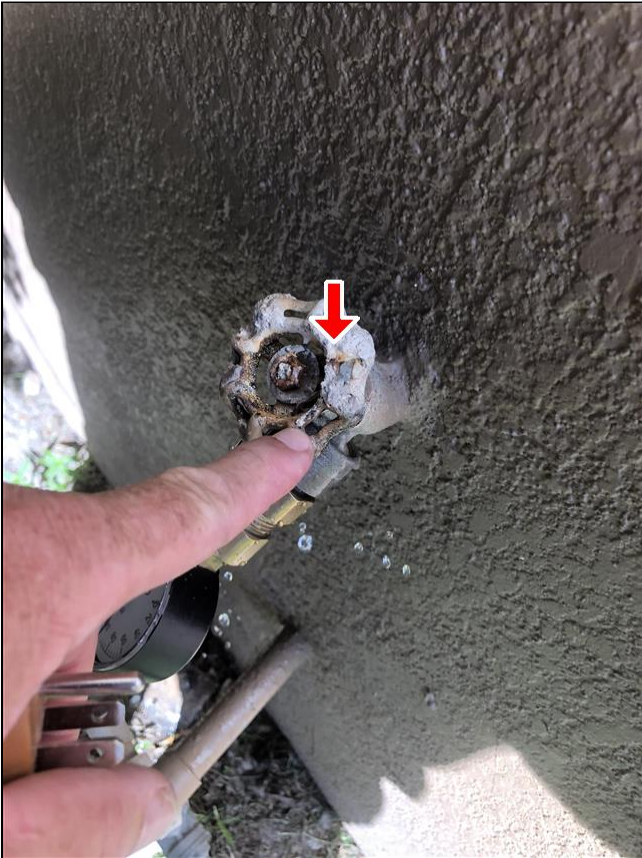
6.1 Item 1(Picture) South Side

6.1 (1) **Water leaking at the handle when turned on at the hose bib located on the South Side of home. Recommend repair by a qualified person.**

(1) Water leaking at the handle when turned on at the hose bib located on the South Side of home. Recommend repair by a qualified person.

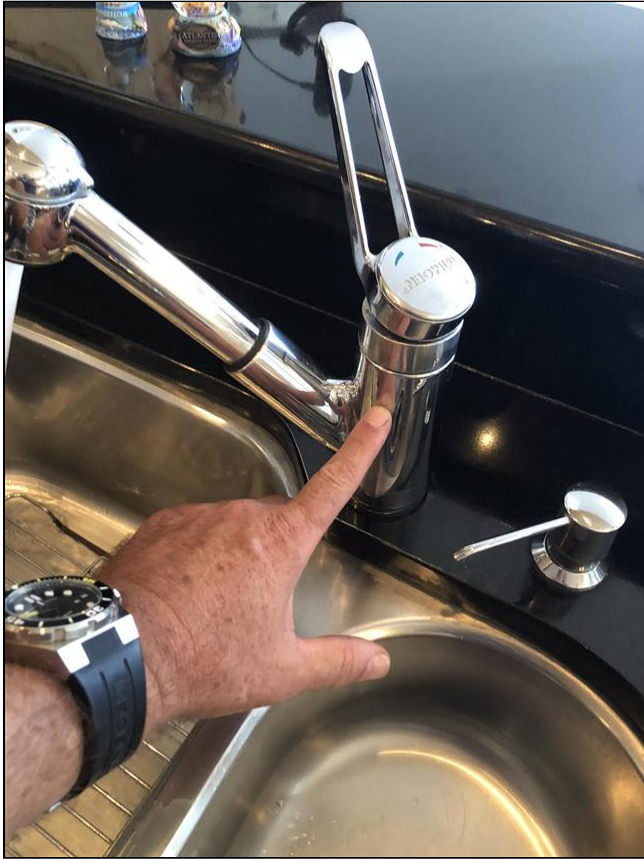
6.1 Item 2(Picture) Kitchen Sink Faucet

(2) **Kitchen sink faucet is loose. Recommend repair by a qualified person.**

(2) Kitchen sink faucet is loose. Recommend repair by a qualified person.

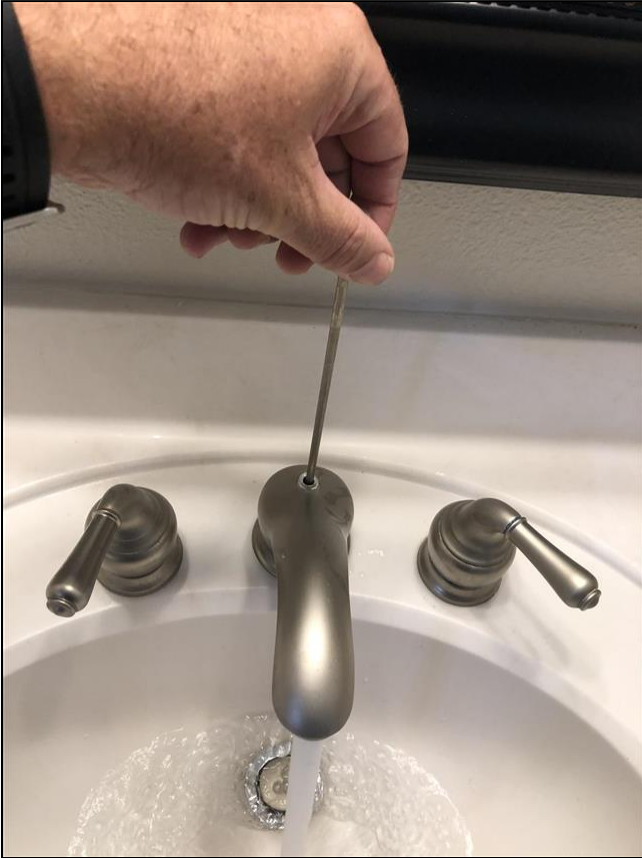
6.1 Item 3(Picture)

(3) Control rod that operates the sink stopper #1 in master bath was not functional at time of inspection. Recommend repair by a qualified person.

(3) Control rod that operates the sink stopper #1 in master bath was not functional at time of inspection. Recommend repair by a qualified person.

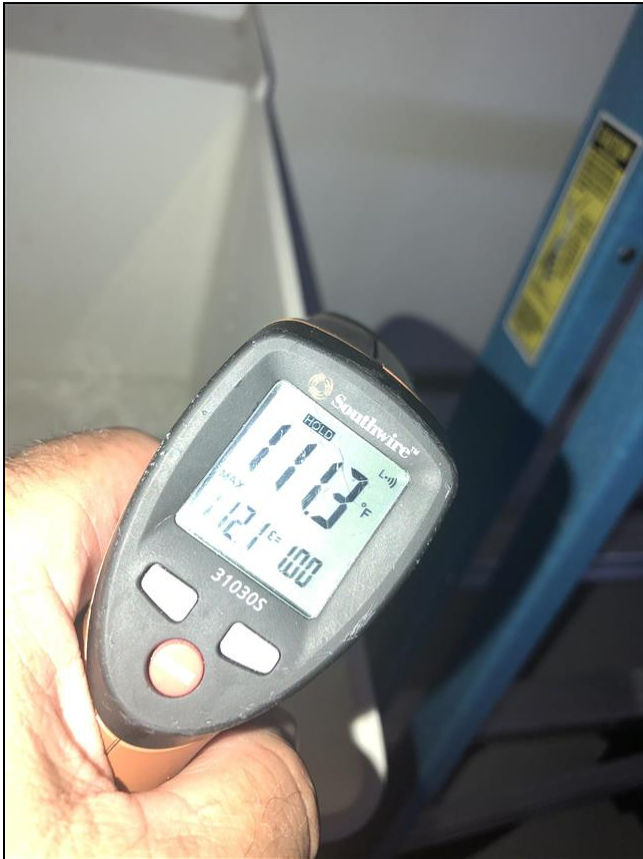
6.2 Item 1(Picture) Hot Water Temp

6.2 Functional at time of inspection.

Age 14 years Life expectancy based on a 20 year life cycle is 6 years left.

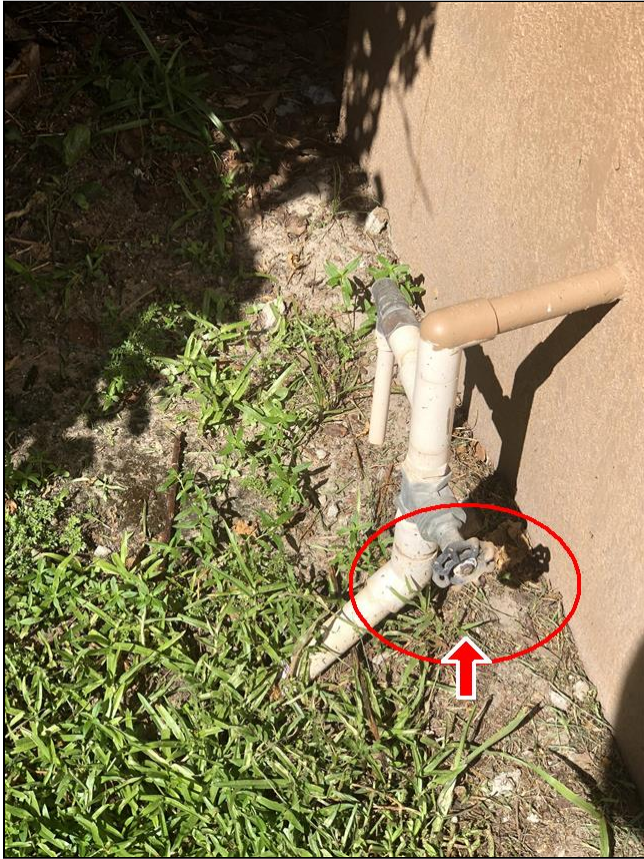
6.3 Item 1(Picture) South Side

6.3 Main water shut off valve located on the South side of homes exterior.

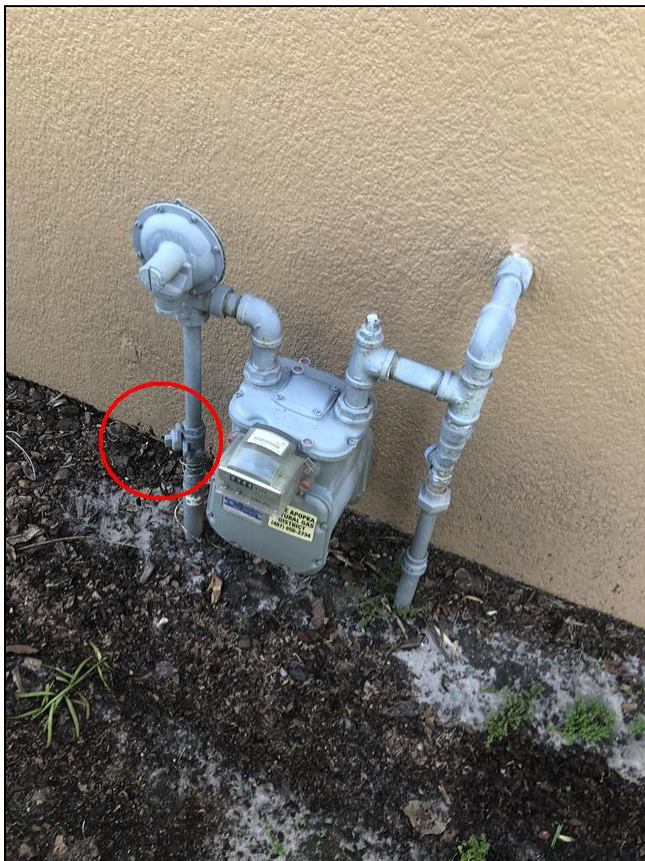
6.5 Item 1(Picture) North Side

6.5 Main fuel shut off located outside on the North exterior wall at the gas meter.

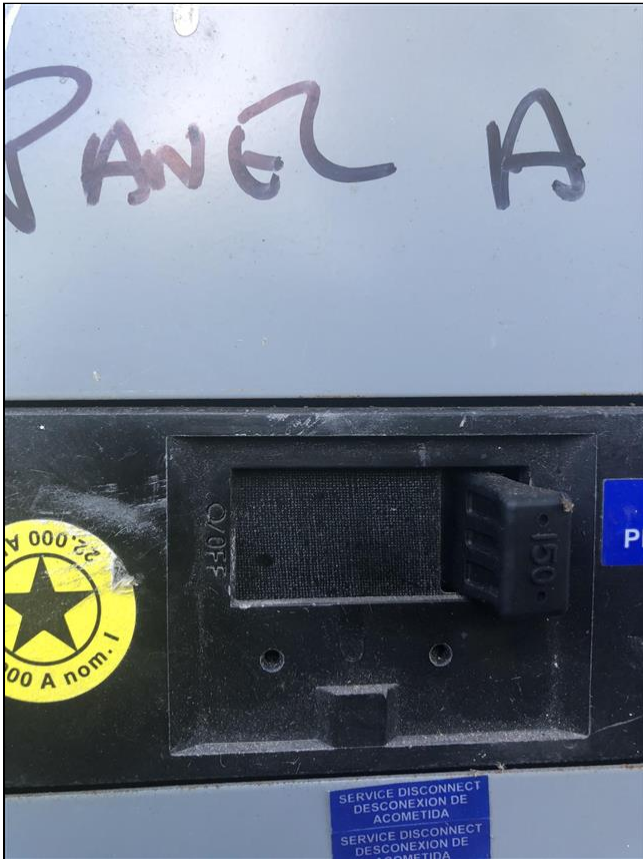
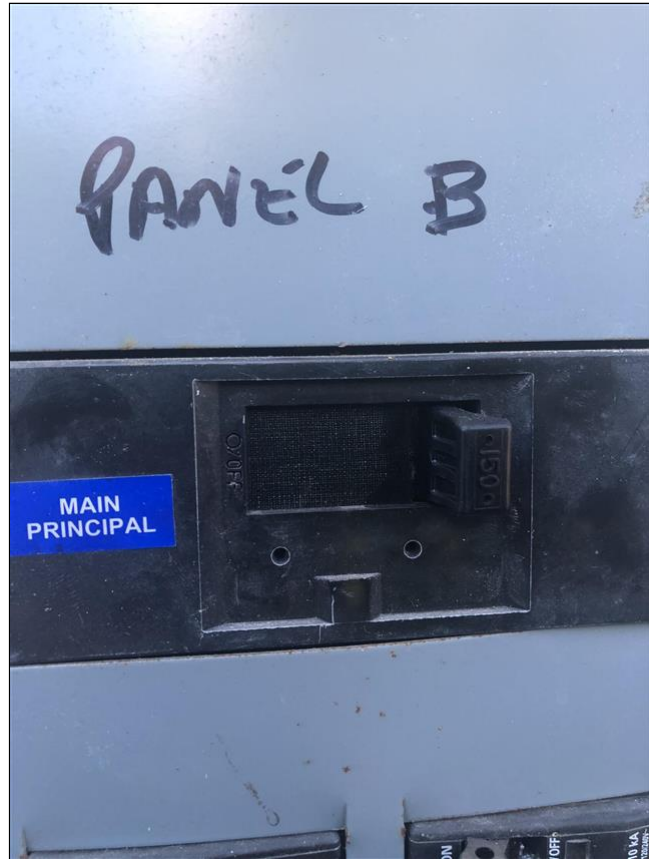
7.1 Item 1(Picture) 150 Amp Main Circuit Breaker

7.1 Functional at time of inspection.

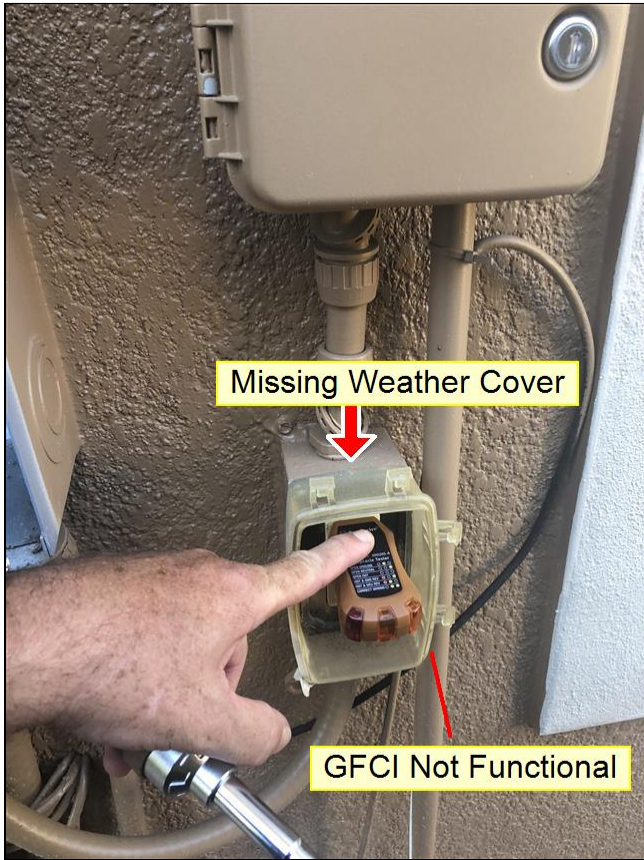
7.5 Item 1(Picture) North Side Exterior

7.5 GFCi located on the North side of home by the irrigation controller was not functional at time of inspection. Recommend replace by a qualified person.

GFCi located on the North side of home by the irrigation controller was not functional at time of inspection. Recommend replace by a qualified person.

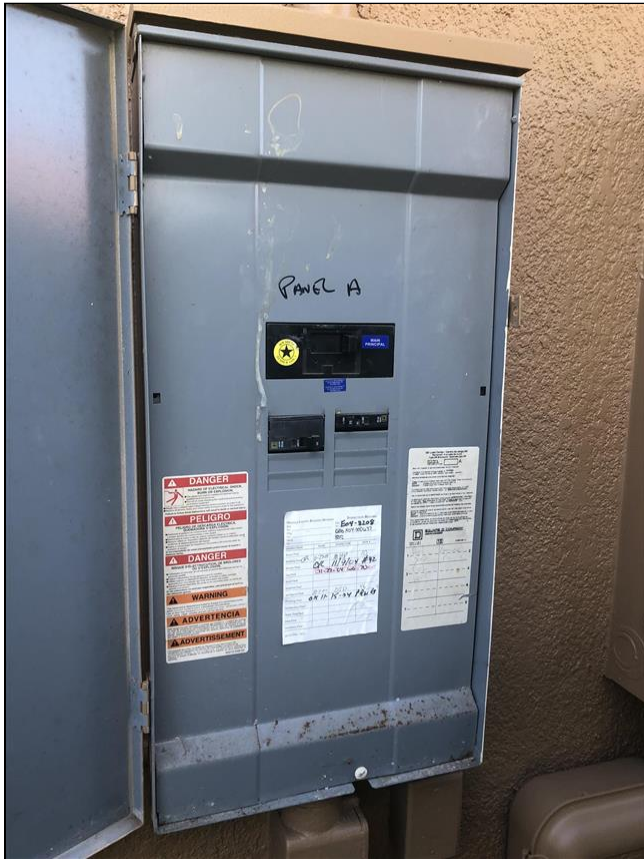
7.6 Item 1(Picture) Main Electrical Panel A

7.6 (1) Main electrical panels A & B is located on the North exterior wall of the home.

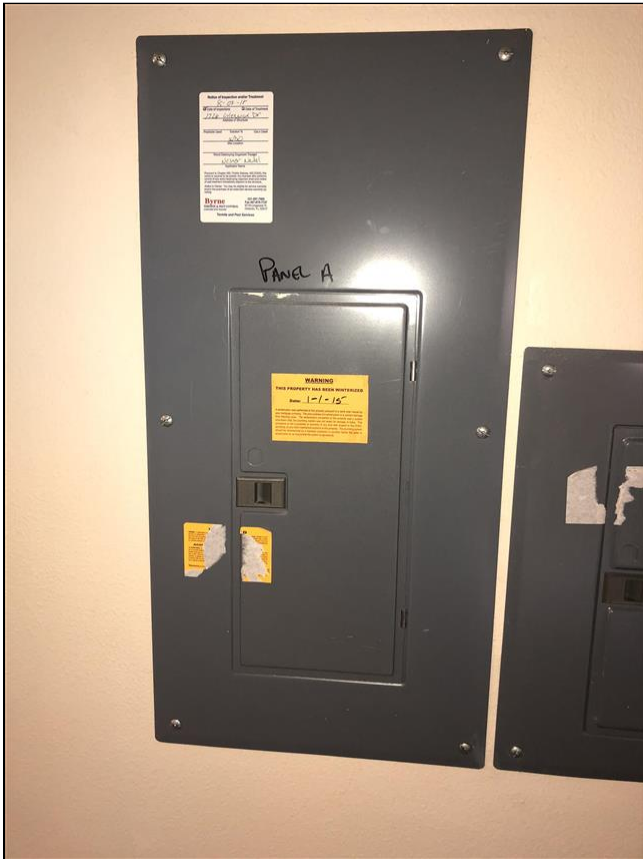
7.6 Item 5(Picture) Sub Electrical Panel A

(2) Sub electrical panel A & B are located in the garage.

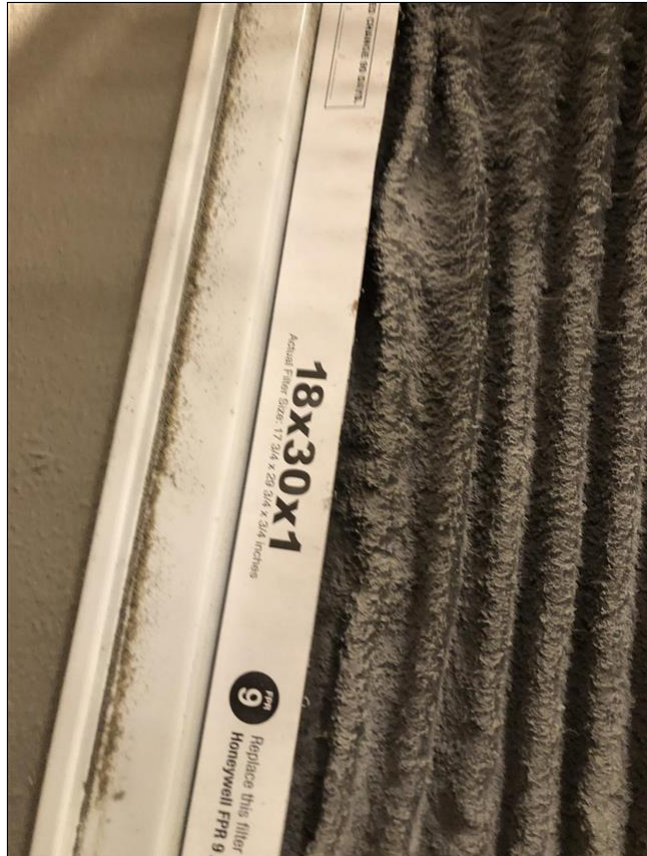
8.3 Item 2(Picture) Filter Dirty Needs Changed System #1

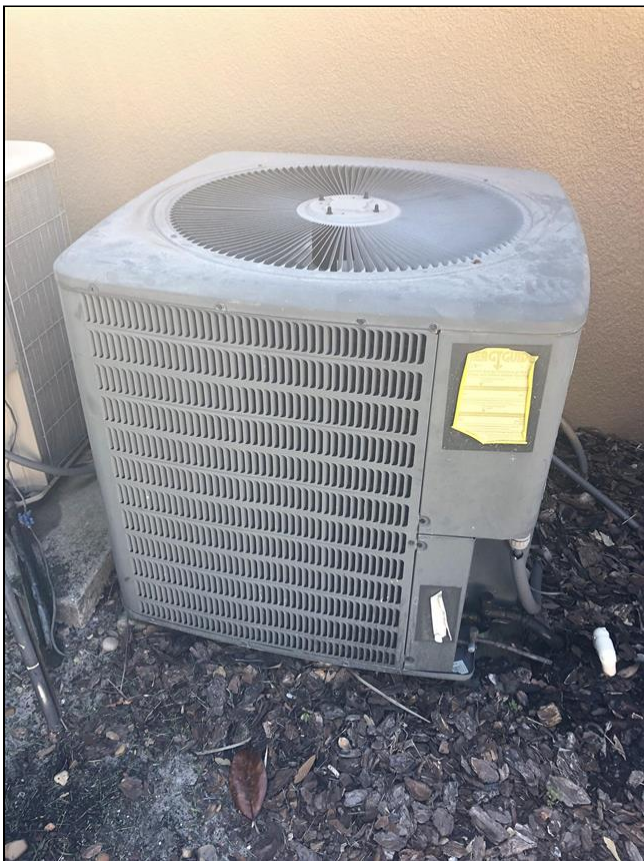
8.8 Item 1(Picture) Outdoor Heat Pump System #1

Lennox - 12 seer 2 - Ton Electric heat Pump System.

Age 14 Years Life expectancy based on a 15 year life cycle is 1 + years left

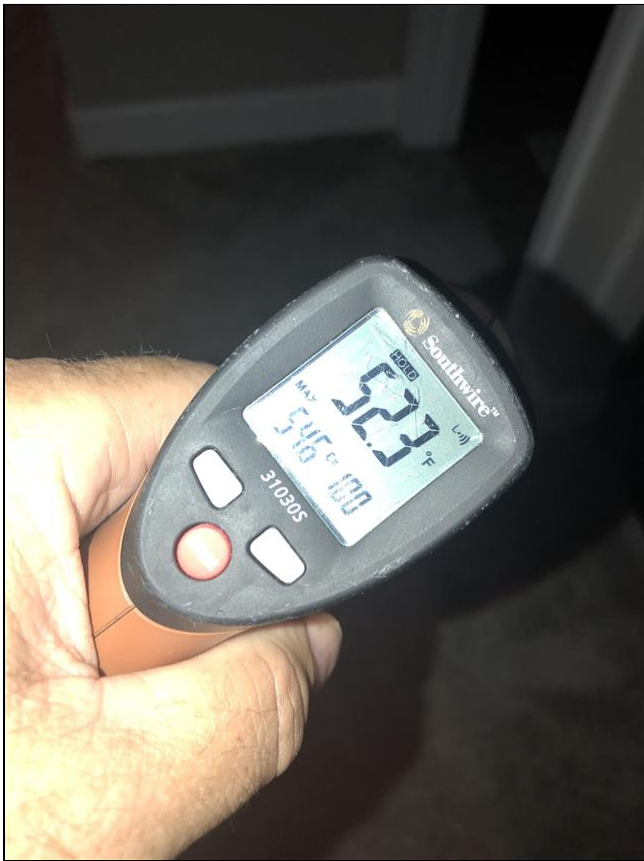
8.8 Item 9(Picture) Supply Air Cooling Temp

(2) The ambient air test was performed by using thermometers on the air handler of Heat pump in cool mode to determine if the difference in temperatures of the supply and return air are between 14 degrees and 22 degrees which indicates that the unit is cooling as intended. The supply air temperature on your system read 52 degrees, and the return air temperature was 71 degrees. This indicates the range in temperature drop is normal.

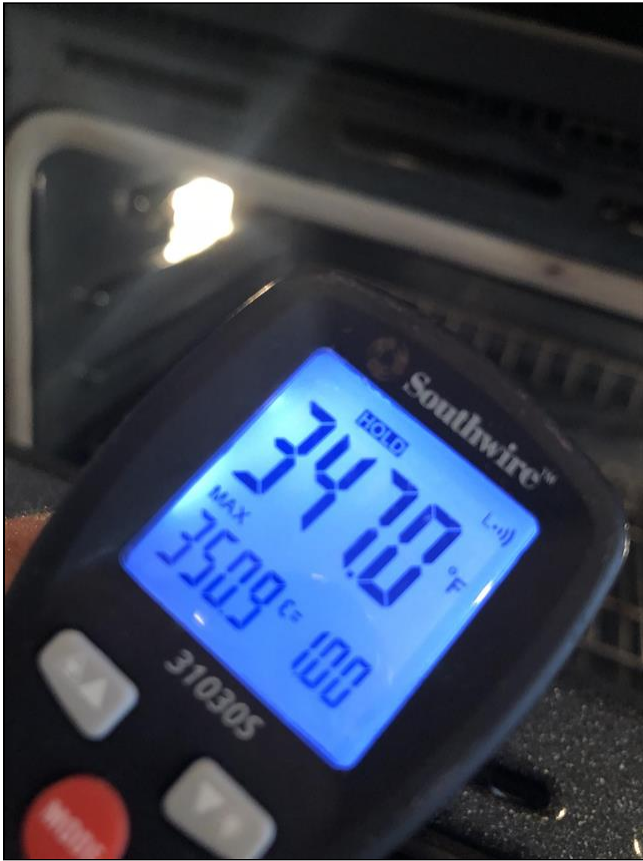
10.1 Item 3(Picture) Upper Oven Temp

Ovens tested at 350 degrees

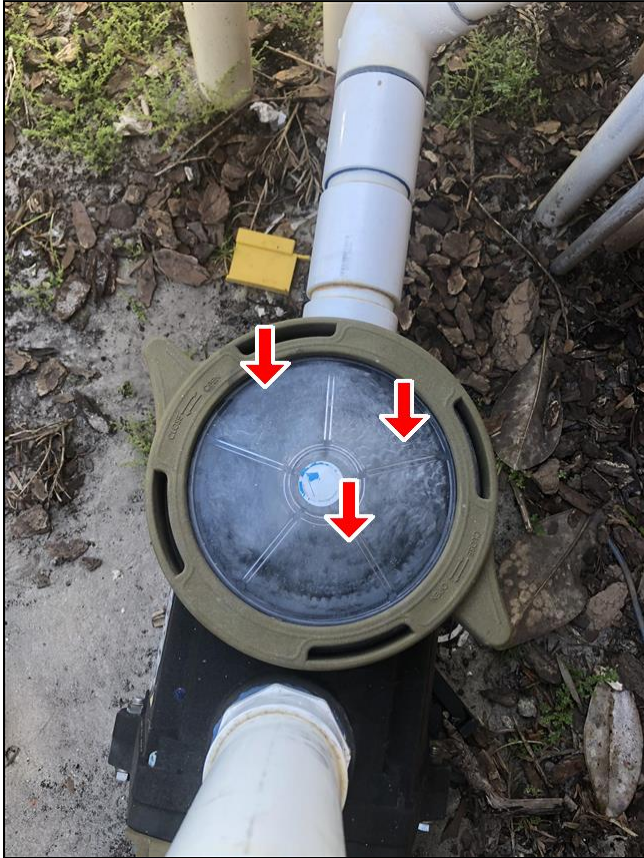
12.0 Item 1(Picture) Pool Pump

12.0 Air bubbles present in the pool pump lid indicating a possible leak. Recommend further evaluation and repair by a pool service provider.

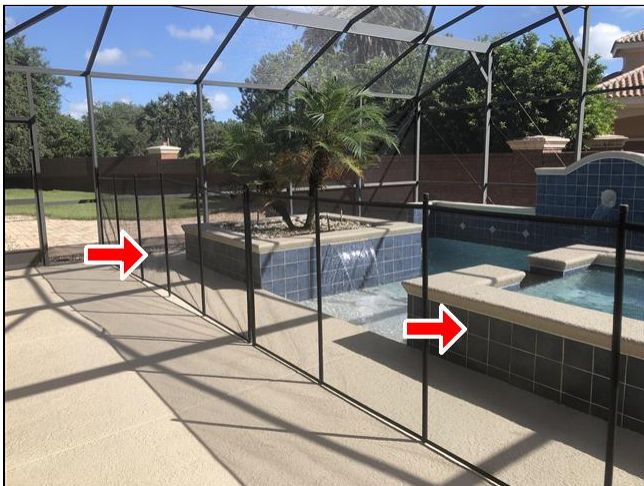
12.9 Item 1(Picture) Pool View

12.9 Raised Hot tub and planter obstructs the view of the pool.
