Property Inspection Report

1234 Sample St.
Inspection Prepared For: Smith John
Agent: Barrett Espinola -

Date of Inspection: 11/9/2020
Year Built: 2003 Size: 4500 SF
Weather: Dry 86

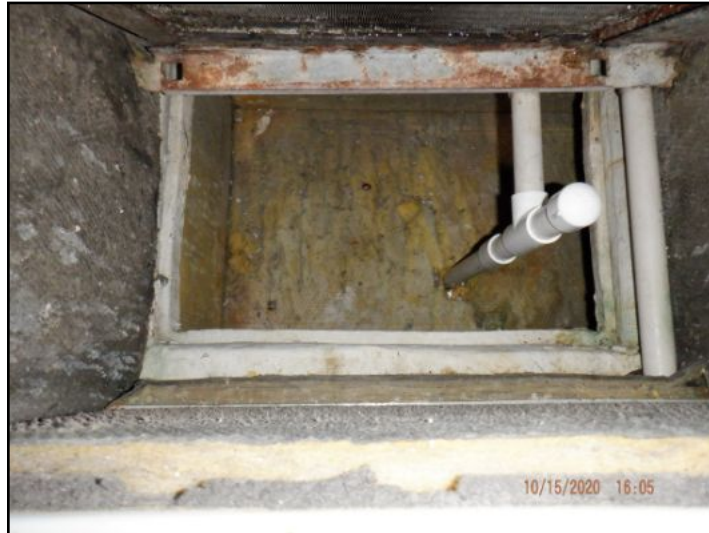
Page 29 Item: 4	Air Supply	<ul style="list-style-type: none"> The air handler located in the master bedroom closet is a Payne 2003 3 ton unit. It performed to industry standards but based on visible conditions at the time of the inspection, I advise complete and proper review of the HVAC system by a qualified professional. I noted corrosion of coils, dirty fins and lack of maintenance. The unit is 17 years old. I recommend budgeting for a new unit.
-----------------	------------	--

Master air handler drain line

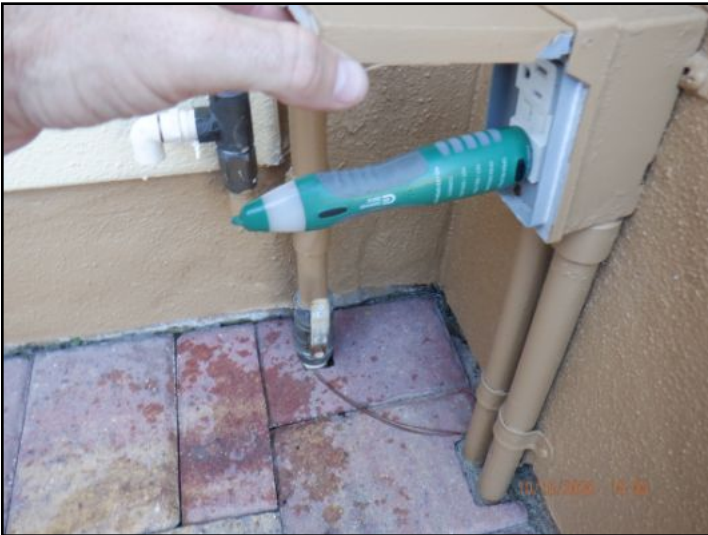
GFCI not functioning

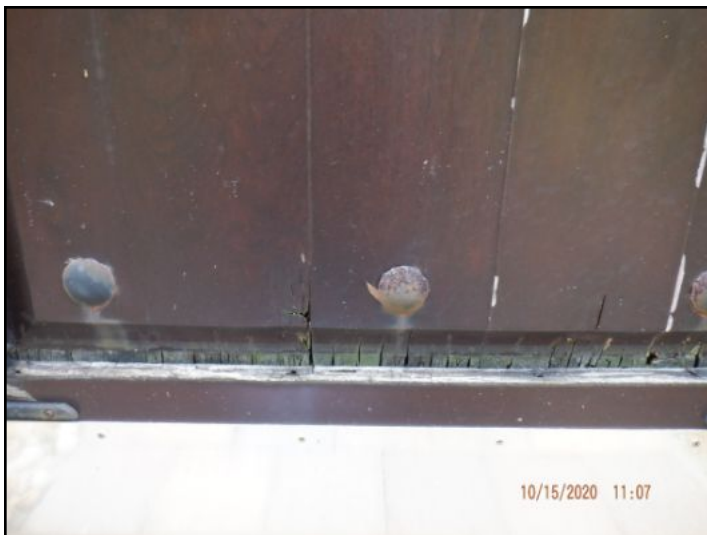
- I observed door and door frame wood rot at the West exterior entry door. I recommend repairs to prevent pest intrusion and further damage.

West entrance wood rot

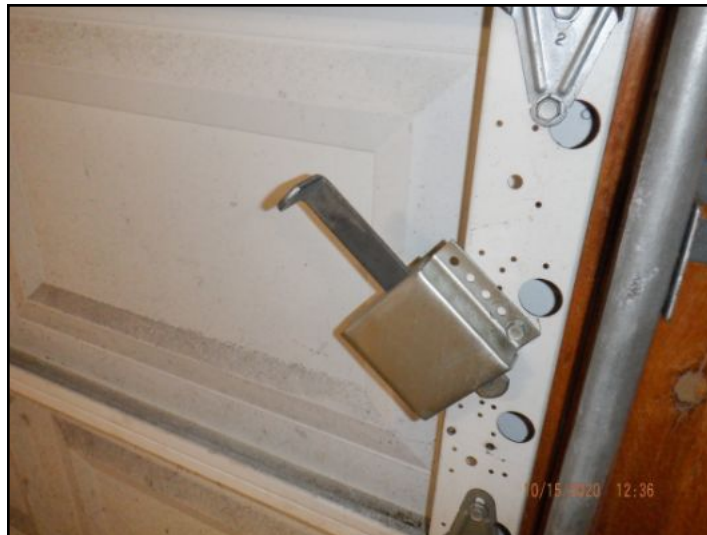
- The garage door has a loose lock . I recommend contacting a qualified contractor to repair the door.

Left door broken lock

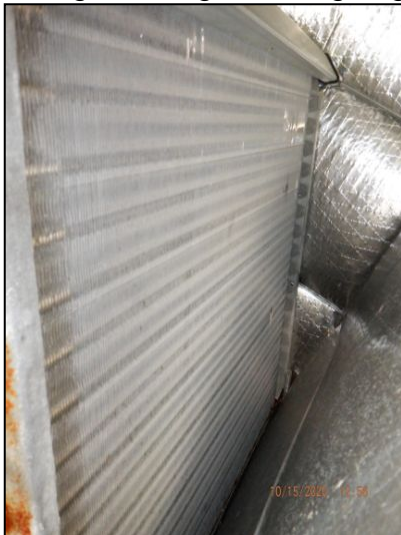
Garage air handler coils

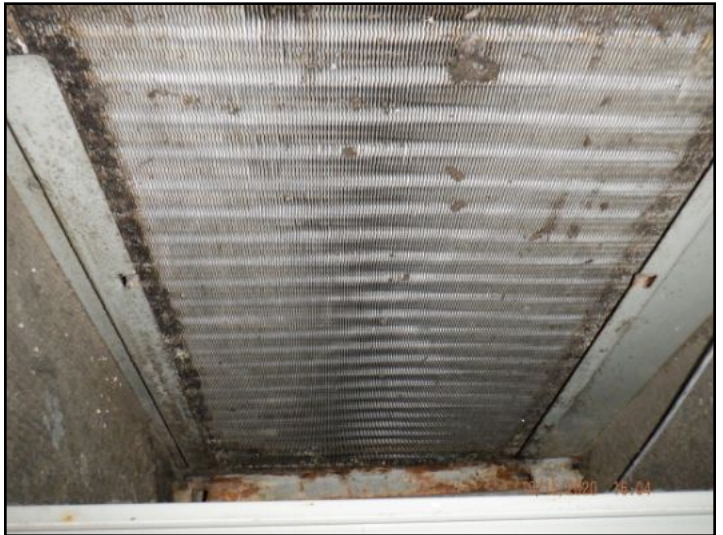
- The air handler located in the master bedroom closet is a Payne 2003 3 ton unit. It performed to industry standards but based on visible conditions at the time of the inspection, I advise complete and proper review of the HVAC system by a qualified professional. I noted corrosion of coils, dirty fins and lack of maintenance. The unit is 17 years old. I recommend budgeting for a new unit.

Master air handler dirty coils

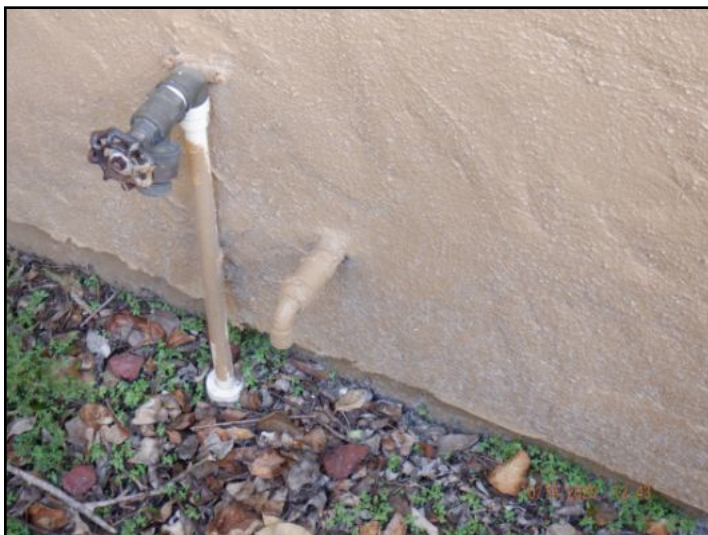
Drains on exterior

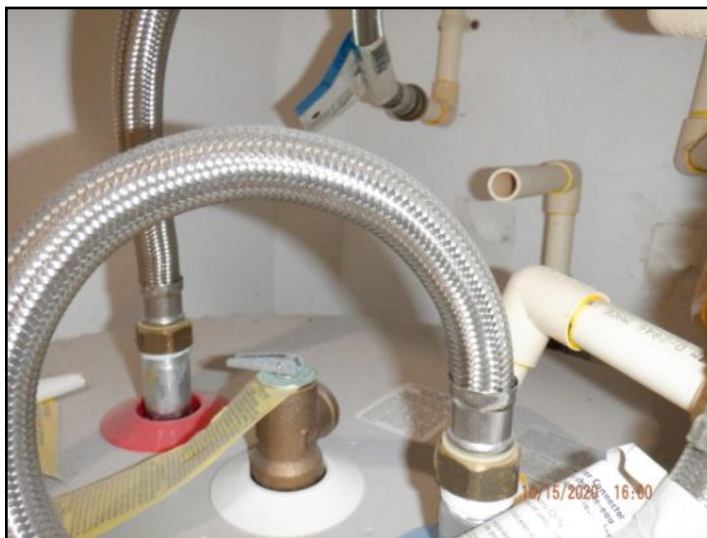
- The Rheem garage water heater TPRV appears to be in satisfactory condition at time of inspection.
- The TPRV piping is not connected at the GE master closet water heater at time of inspection. This is a serious safety concern and needs to be corrected. I recommend contacting a licensed plumber for repairs.

Master closet TPRV is not connected

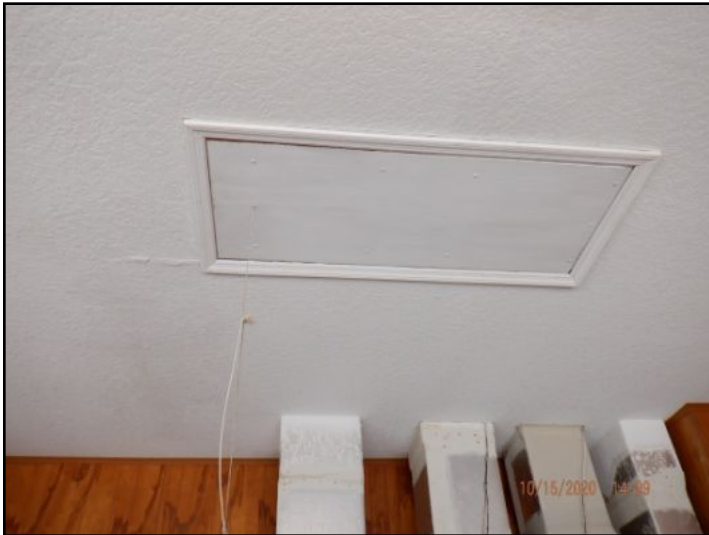
Pull down in garage

- Pull Down Ladder located in: garage
- Scuttle Hole located in: master bedroom closet.
- **IMPROVE:** The attic access is not insulated. Expect some energy loss through convection. Recommend insulating attic access hatch cover @ pull down ladder @ with a batt of fiberglass insulation to reduce energy expenses. See diagram for detail.

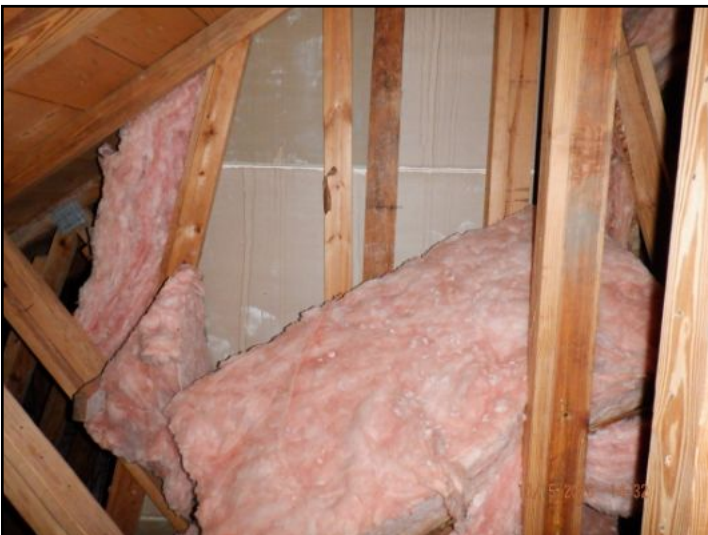
- Attic appeared to be of sound structure during time of inspection.
- Evidence of past or present leaks, dry at time of the inspection. (see roof skylight section) Monitor for leaks &/or have roofing contractor evaluate.

Water stains around skylight dry

- The sky light may be past its serviceable life. I observed signs of excessive leaking in the attic area that were dry at time of inspection. I recommend having a licensed roofing contractor evaluate and replace/repair as needed.

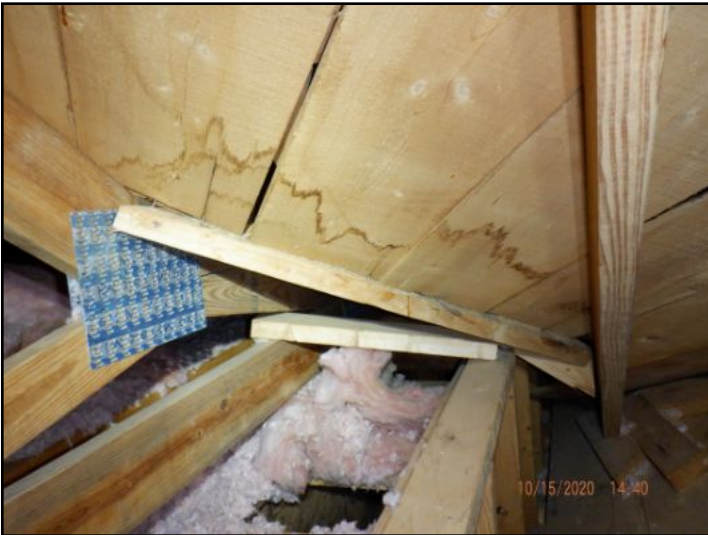
Water stains around skylight dry
