Property Inspection Report

1234 Sample St.
Inspection Prepared For: Smith John
Agent: Barrett Espinola -

Date of Inspection: 11/9/2020
Year Built: 2003 Size: 4500 SF
Weather: Dry 86

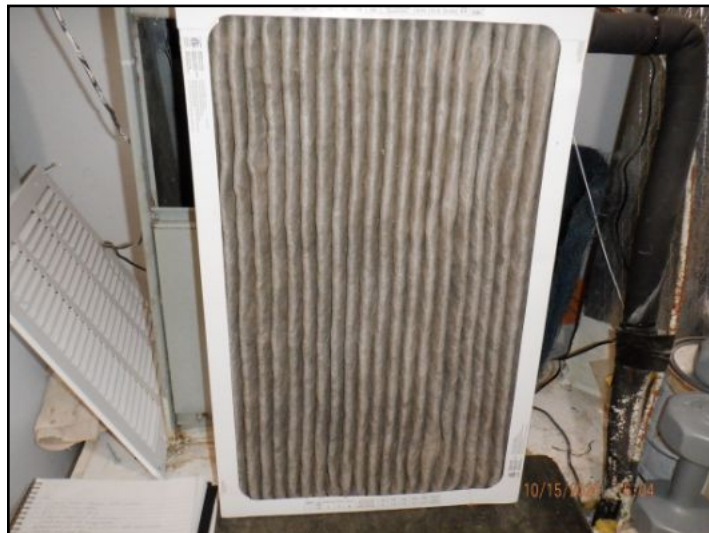
Page 32 Item: 6 | Filters

Master replace filter

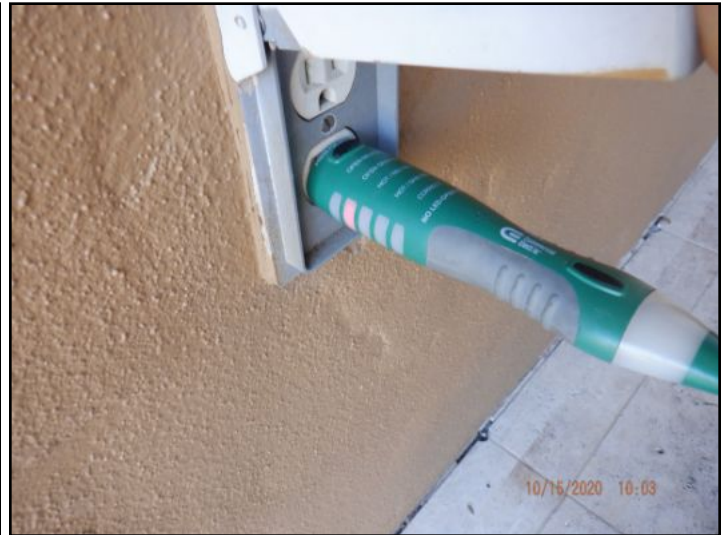
- Open ground (or 2-wire) outlets present. This means that the 3rd (round) part of an appliance plug is not getting ground protection. This may be a concern with items such as computers and electronic devices.

Front porch open Ground

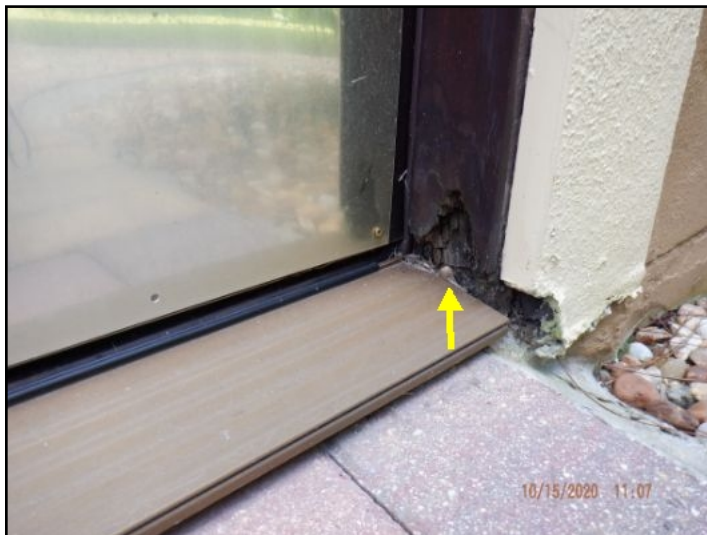
Left entrance wood rot

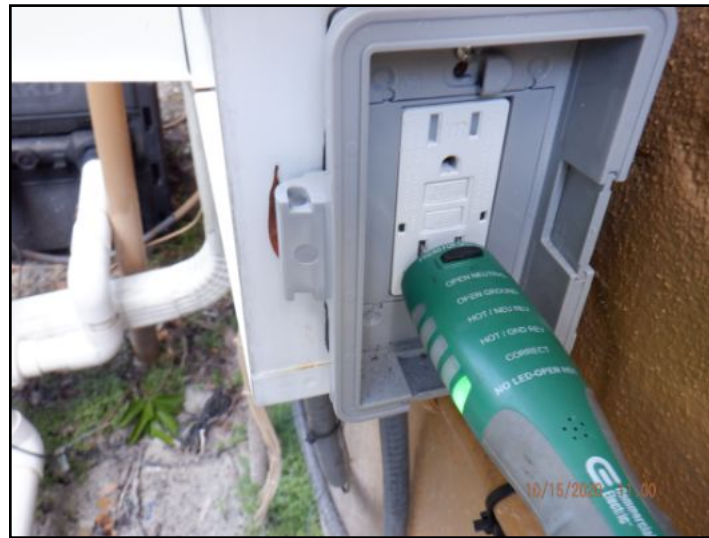
- GFCI had power when tripped. This is often the result of miswiring and is usually easily fixed. Advise repair or replacement as needed.

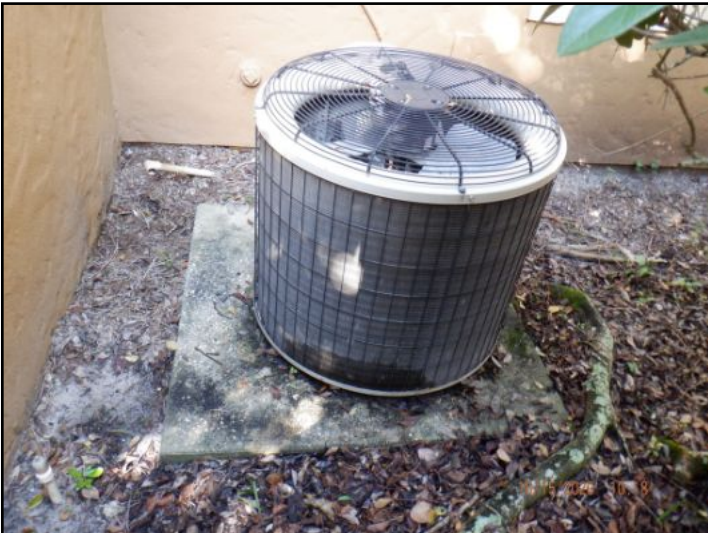
- The west unit is a Trane 2007 3 Ton unit that appeared functional at the time of inspection.
- The East AC unit is a Payne 2003 3 Ton unit. The unit performed to industry standards during time of inspection. I observed excessive vibrating and noise at time of inspection. The average life expectancy for air conditioners is 15-20 years and this unit is 17 years old. I recommend having a qualified professional further evaluate and budgeting for a new unit.

East Payne 2003 3 Ton R22

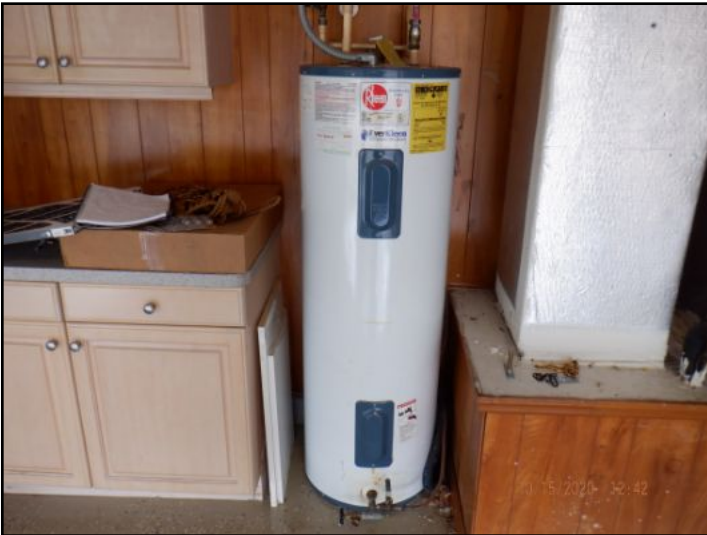
- The Rheem water heater located in the garage appears to be in satisfactory condition at time of inspection. The average life expectancy for water heaters is around 12 yrs. This unit is 15 years old. I recommend budgeting for a new unit.
- The Master bedroom closet water heater appears to be in serviceable condition but has deficiencies noted with the Temperature Pressure Relief (TPR) valve and discharge pipe.(see TPRV section)

Rheem 2005 50 gallon

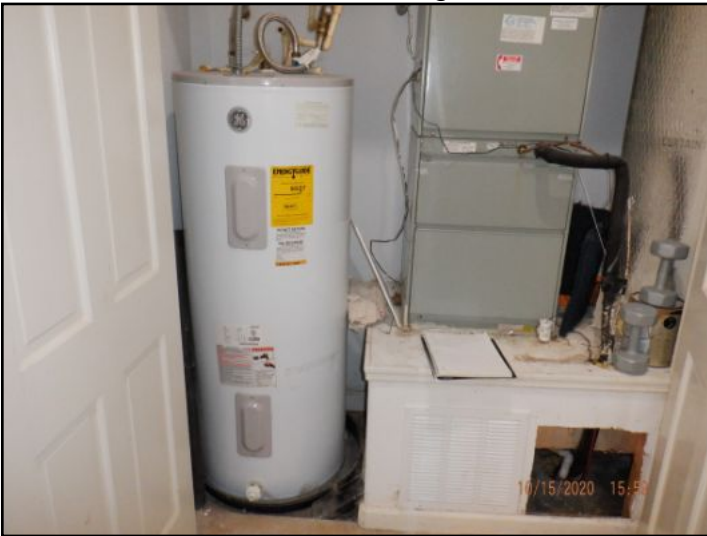
Location master bedroom closet

- The Rheem garage water heater TPRV appears to be in satisfactory condition at time of inspection.
- The TPRV piping is not connected at the GE master closet water heater at time of inspection. This is a serious safety concern and needs to be corrected. I recommend contacting a licensed plumber for repairs.

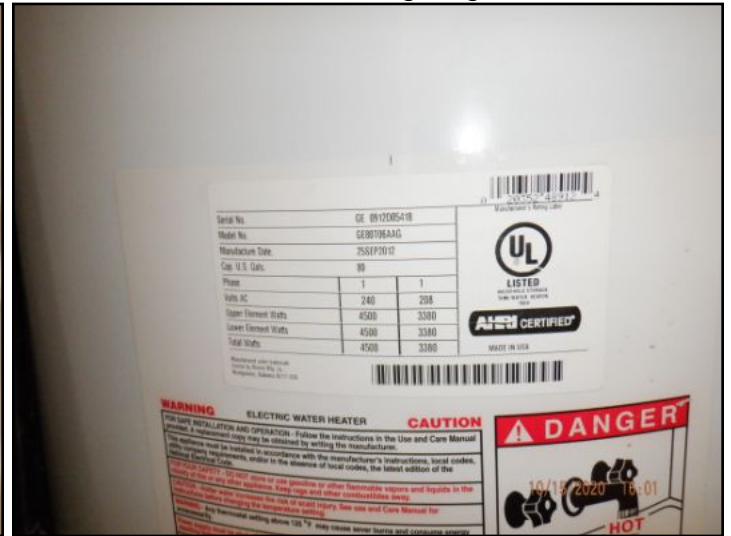
GE 80 gallon 2012 Master closet

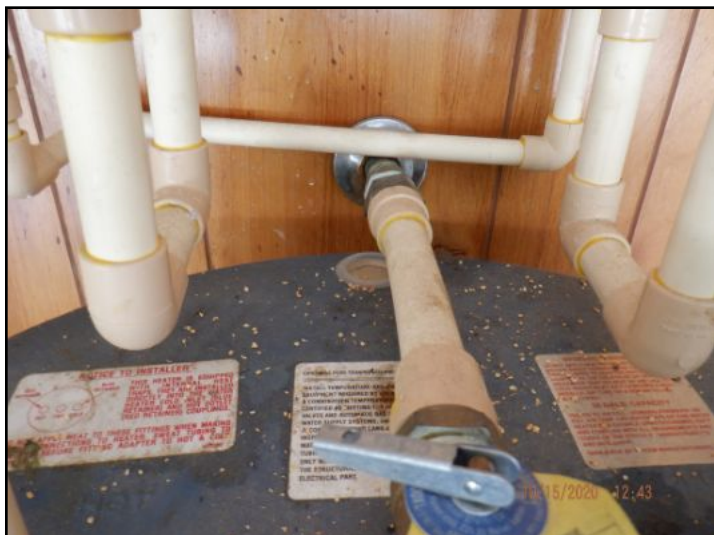
Drains on exterior

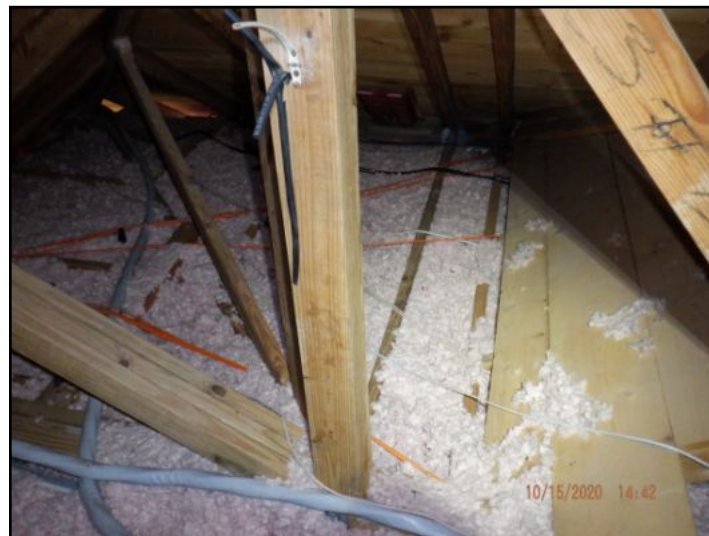
- Insulation that is settled does not perform to the R-Value that it once did.
- **IMPROVE:** The house has only a minimal amount of visible insulation. Expect high heating and cooling energy costs. Recommend having the home professionally insulated to reduce energy expenses.

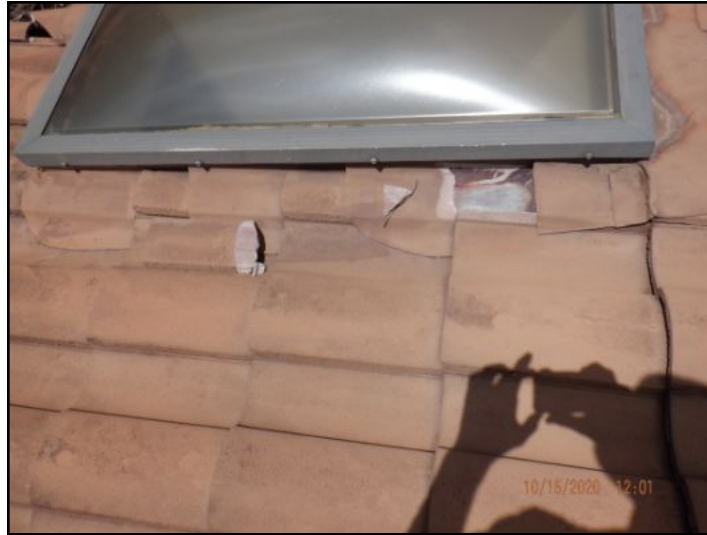
- The sky light may be past its serviceable life. I observed signs of excessive leaking in the attic area that were dry at time of inspection. I recommend having a licensed roofing contractor evaluate and replace/repair as needed.

Flashing damage

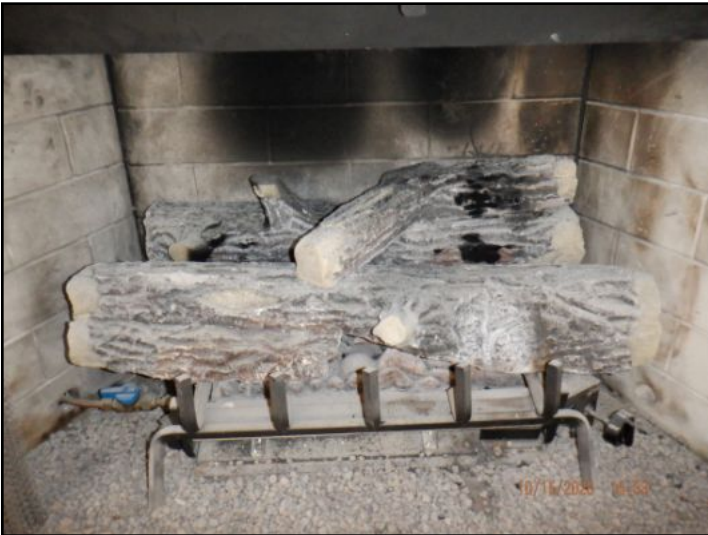
Gas fireplace

- Have a gas fireplace professional service/evaluate fireplace before operating.
- The fireplace appears to be in fair visual condition. Was operated and observed as functional during inspection.

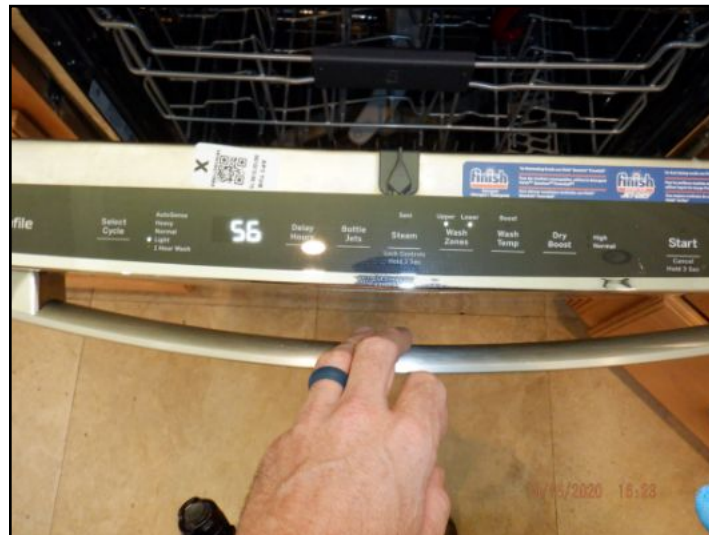
- Operated appeared functional at time of inspection.

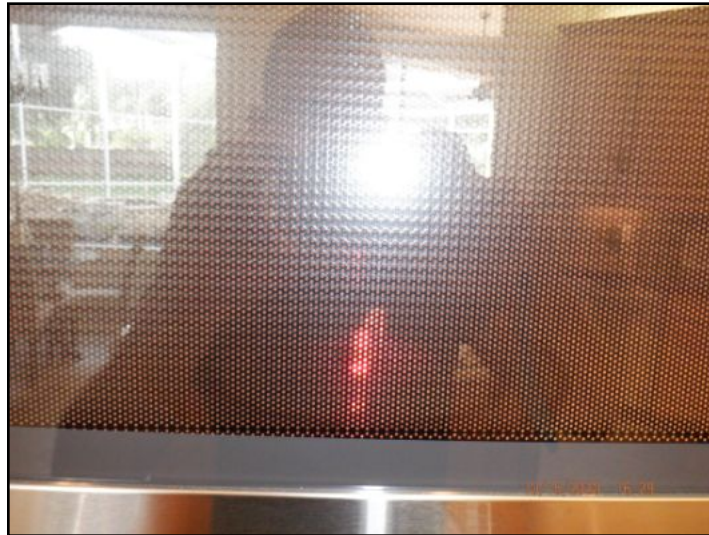
- Built-in microwave ovens are tested using normal operating controls. Unit was tested and appeared to be serviceable at time of inspection. Leak and/or efficiency testing is beyond the scope of this inspection. If concerned, client should seek further review by qualified technician prior to closing.

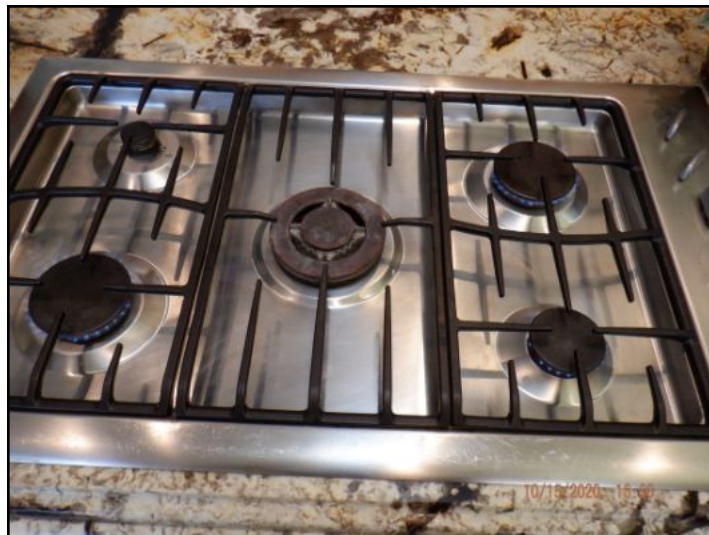
- Gas cook top noted.
- All heating elements operated when tested.

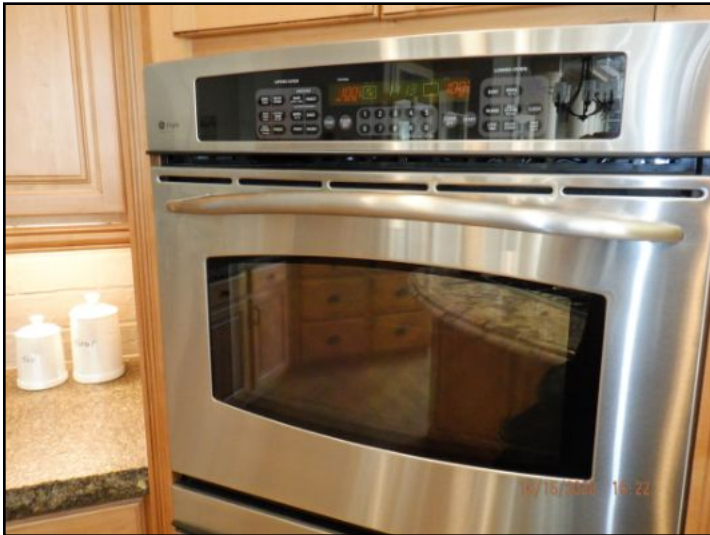
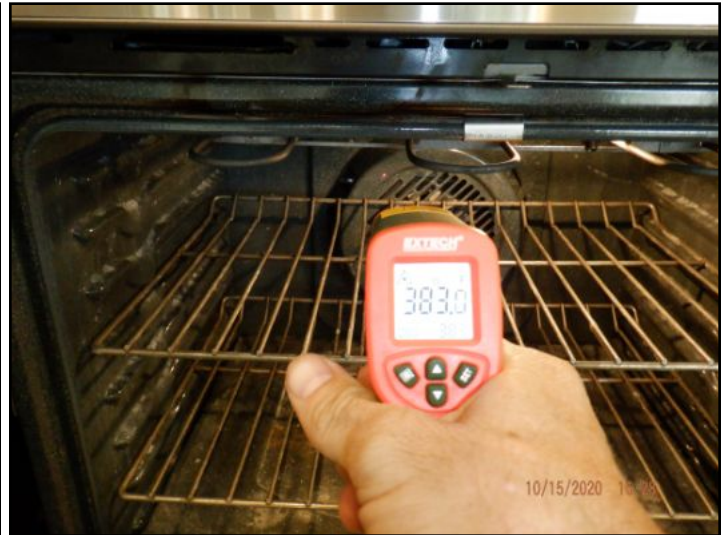
Bake

- Oven: gas burners
- All heating elements operated when tested.

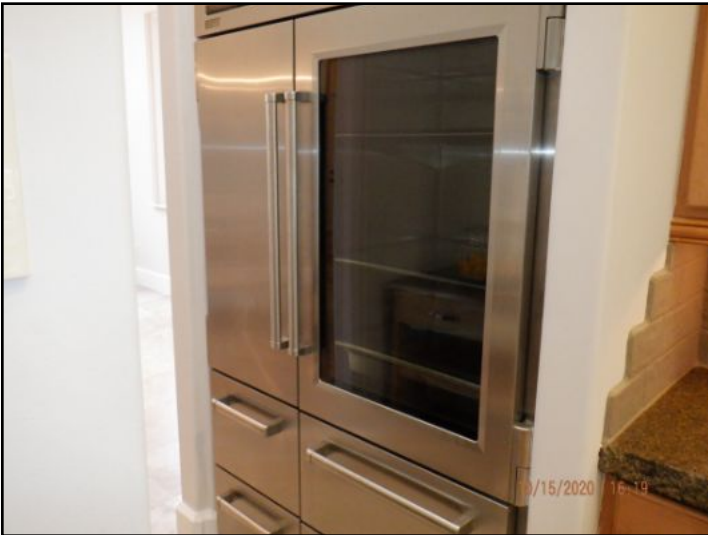
Sub zero

- The refrigerator appeared functional during time of inspection.

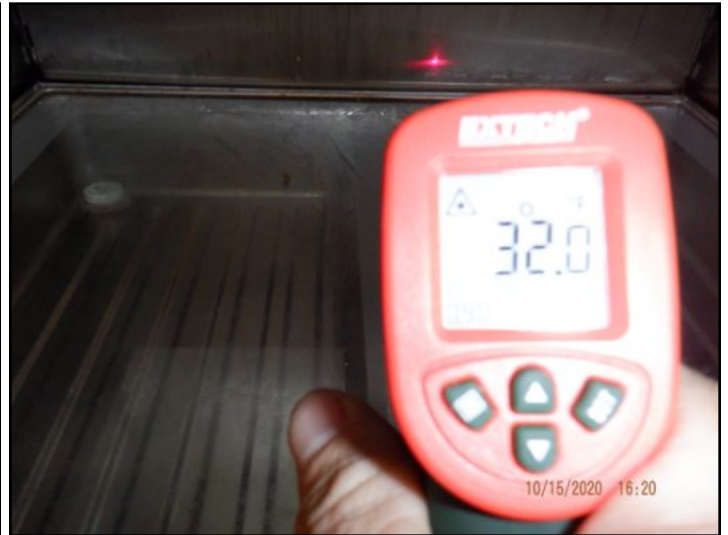
32 degrees

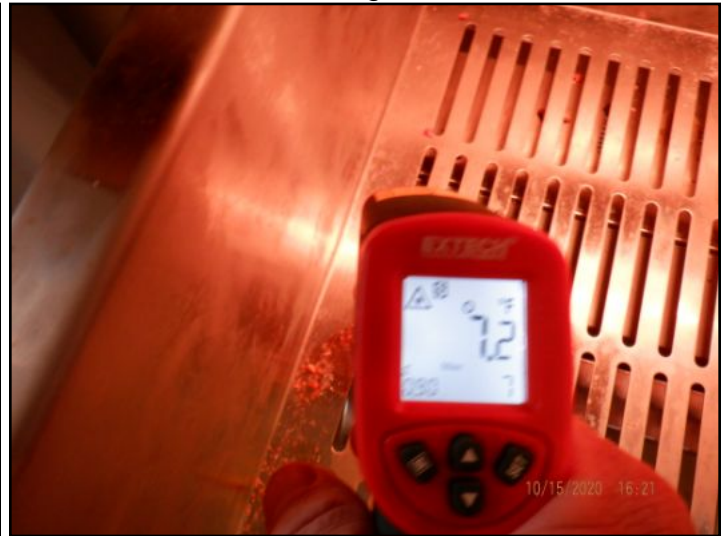
Freezer 7 degrees

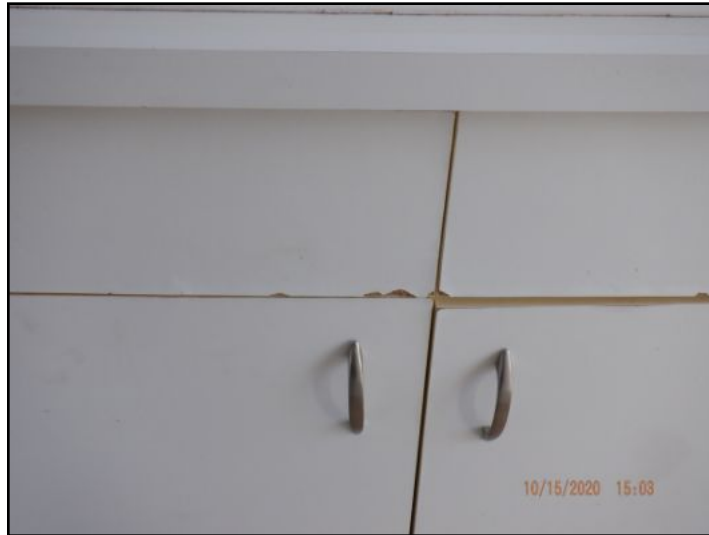
- Appeared functional but in poor condition, at time of inspection.
